# Restoring Mrigadayavan Palace:

## Understanding Causes of Concrete Deterioration and Determining Viable Concrete Rehabilitation Methods

The Mrigadayavan Palace in Cha-am, Thailand has faced the effects of deterioration on concrete structures. The project goal was to preserve and rehabilitate the damaged concrete by exploring various concrete restoration techniques and determining viable methods, as requested by the Mrigadayavan Palace Foundation, to complete a restoration project for the palace's 100th anniversary in 2024. Throughout the project, information was collected through observations, fieldwork, and research. Recommendations to address the deteriorating concrete structures came in the form of a decision tree with extensive criteria for evaluating and determining which techniques achieved the desired outcome. Additionally, web pages, QR codes, and pamphlets were produced as educational materials for visitors.

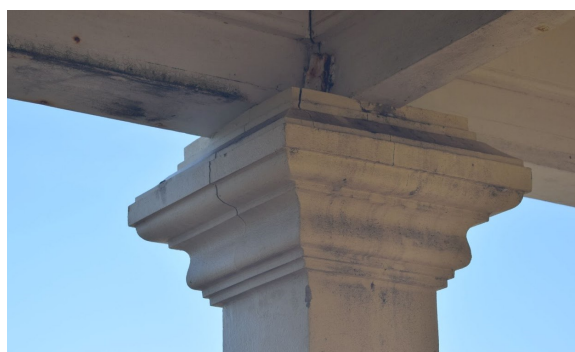
Figure 13. Cracks that form on the special design on top of a column

From observations, the diameter of the steel reinforcement in the concrete columns is approximately 9 to 10 millimeters. The size of the steel reinforcement that is used in the concrete columns is identical throughout the Palace. Furthermore, the steel reinforcement embedded at the top of the original concrete column was not for extra support for the whole concrete column, but it was there to support the special design that the top of the concrete column had. Any cracks or corrosion that exist on this special design would not affect the stability of the rest of the column. Cracks on the special design on top of the column can be seen in *Figure 13*.

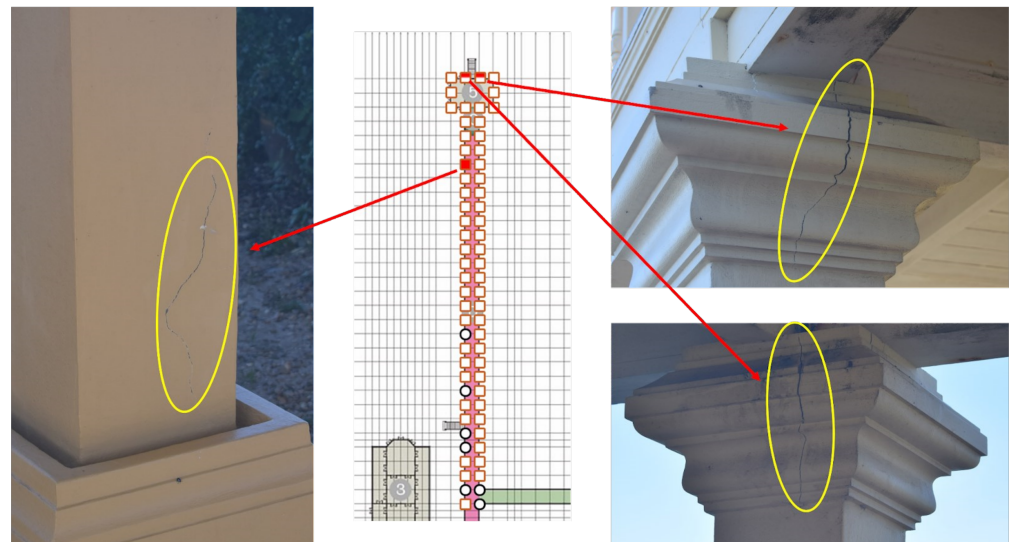
look into this area with photos of the cracks in the area can be seen in *Figure 16*. In this area, a total of sixty-six concrete columns were recorded. Fifty-nine concrete columns or 89.4% of the columns in this area had steel reinforcement throughout the body, and only seven concrete columns had steel reinforcement at the top and base of the column. This area was renovated about three years ago which makes it the most recently renovated area. Only three cracks in concrete columns were observed in this area and the pattern of cracks was all vertical. Two of them were found at the top of the column and one column had cracks in all three locations.

Figure 16. Area one: outer court bathing pavilion

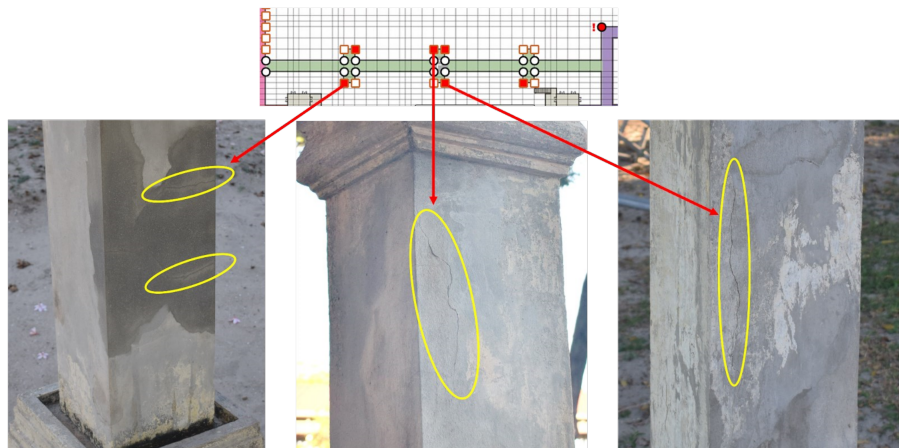
For area two (middle-box), the **linking corridor between the two courts**, a closer look into this area with examples of the cracks in the area can be seen in *Figure 17*. A total of twenty-four concrete columns were recorded in this area. In the recorded data, twelve concrete columns of 50% of the concrete columns had steel reinforcement throughout the body and twelve concrete columns had steel reinforcement at the top and base of the column. This area was last renovated about thirty years ago. There were six columns in this area that had cracks in all three locations and it all happened to the columns that had steel reinforcement throughout the body of the column.

Figure 17. Area two: linking corridor between the two pavilions

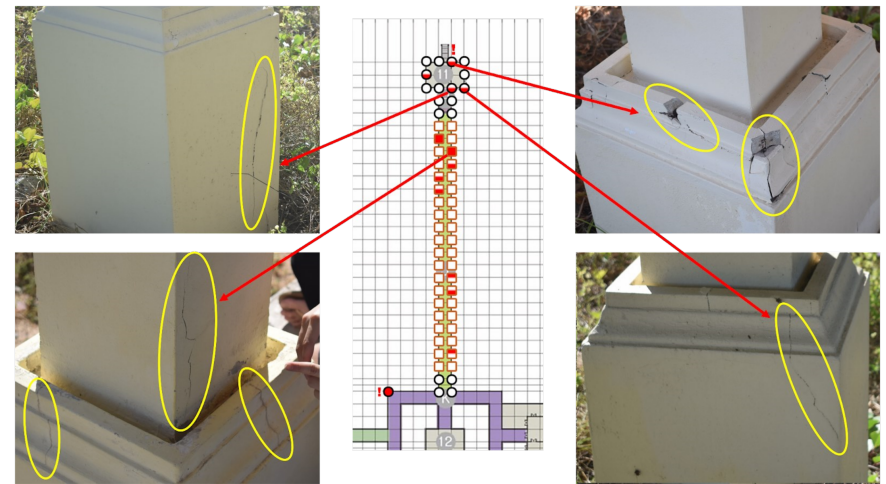
Figure 18. Area three: inner court bathing pavilion

For area three (right-box), the **Inner Court Bathing Pavilion**, a closer look into this area with examples of the cracks in the area can be seen in *Figure 18*. In this area, a total of fifty-eight concrete columns were recorded. Forty concrete columns or 69% of the concrete columns in this area had steel reinforcement throughout the body, and eighteen concrete columns had steel reinforcement at the top and base of the column. This area was renovated about thirty years ago as well. Eight columns had steel reinforcement throughout the body that had cracks in them, and four columns that had steel reinforcement at the top and base that had cracks in them. Both vertical and horizontal crack patterns were observed in this area. Most of the horizontal cracks in the sampling area can be found in this area.

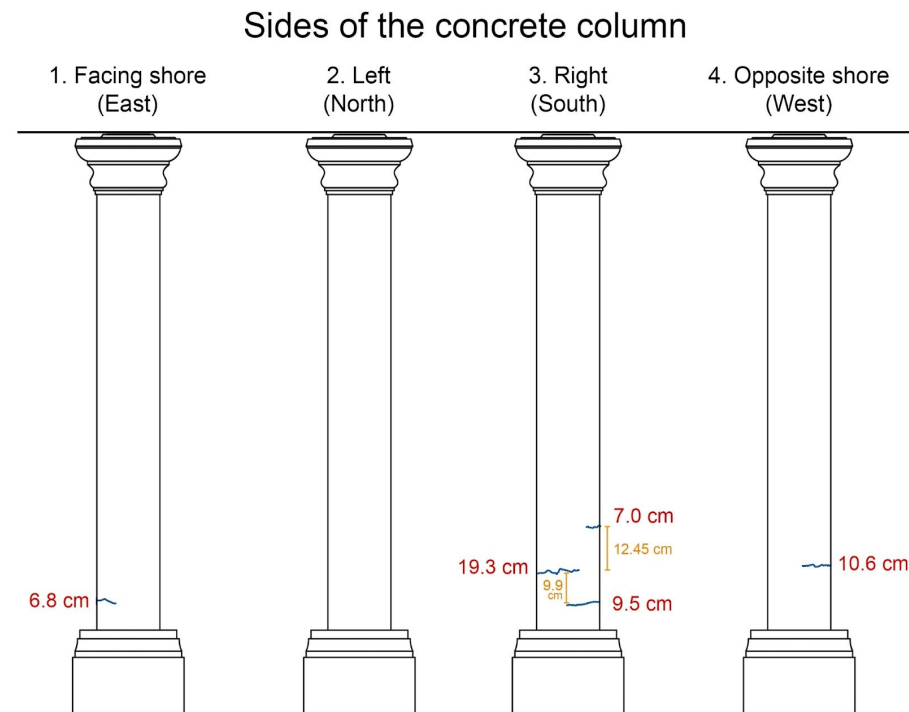
that lengthy. Based on observation, the cracks on the columns were mostly on the surface and were very shallow in depth. An example of the crack map of cracks on the concrete columns can be seen below in *Figure 20*. This specific crack map only shows the dimension of length. The width was not measured because it was too small to get an accurate measurement.

Figure 20. Example of a crack map on concrete columns with length

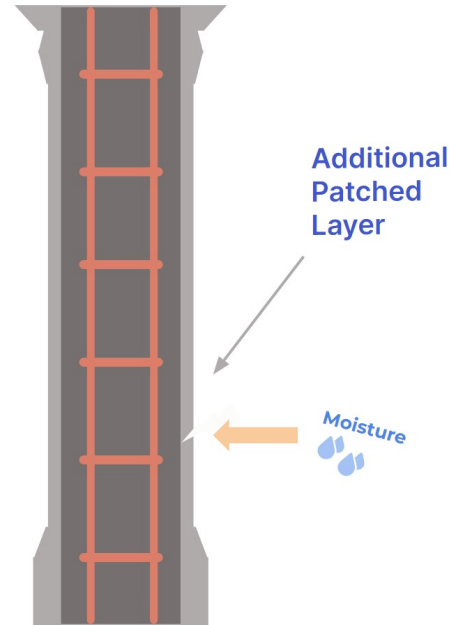
The outer surface of the concrete column is the additional patched concrete layer that was added to the main column. The cause of the cracks in the outer surface of the concrete column could not be stated with confidence yet, but some possible causes would be the instability of the upper wooden structure that sits on top of the concrete columns which is mentioned in detail previously. Another possible cause was that the outer surface/ additional patched layer was not applied well enough, as there was an insufficient surface area for the additional patched layer to hold on to the core of the column. This hypothesis was put together based on observing the educational columns that the Palace put on display. The additional patched layer could be seen to be very thin, and no materials were put in between the patched layer and the core of the column to increase the adhesion. Therefore, minor cracks could start forming on the surface and easily let moisture seep in and cause further corrosion, as illustrated in *Figure 21*.

Figure 21. Illustration of the additional patched layer of concrete on the reinforced concrete column

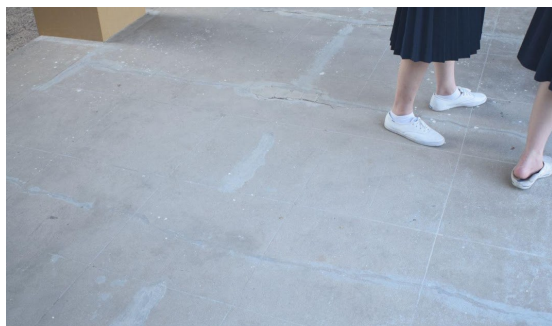
Small-scale repair processes happened throughout the years, as walkways showed some signs of minor repairs. The timeline of the repairs is uncertain due to the lack of past restoration records. Nevertheless, differences in concrete color on the walkways in *Figure 23* showed that the concrete patching technique had been done in the past restorations. When cracks occurred on the concrete walkway, the new concrete paste would be used to patch up on the surface.

Figure 23. Signs of the difference in concrete colors in the concrete walkways

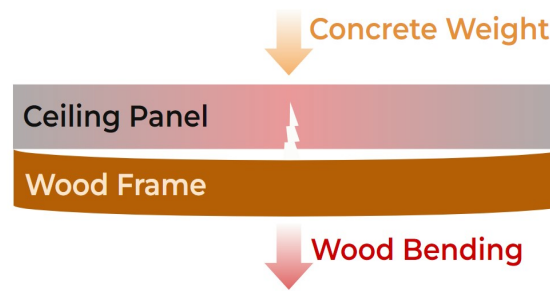
Figure 26. Schematic explanation of the crack in the concrete ceiling panel

**Architectural errors and deterioration** played a major role in causing **cracks** on the concrete ceiling panels. After discussion with the Palace Foundation, it was determined that the cracks on the concrete ceiling panels were caused by the instability of the wood framework. As time passes, the wood framework that supports the weight of the concrete panels bends. This creates an uneven weight distribution of concrete panels onto the wood framework. The arched part of the wood framework could support less weight of the concrete pane causing concrete ceiling panels to crack in the middle area between two edges as explained by *Figure 26*.
