Mitigating the Effects of Flooding in the Khlong Toei Slum of Bangkok, Thailand

An Interactive Qualifying Project Report
Submitted to the Faculty of
WORCESTER POLYTECHNIC INSTITUTE and
CHULALONGKORN UNIVERSITY
In partial fulfillment of the requirements for the
Degree of Bachelor of Science
In cooperation with
The Duang Prateep Foundation
Submitted on February 22nd, 2017

Appendix M: Maps for the Duang Prateep Foundation

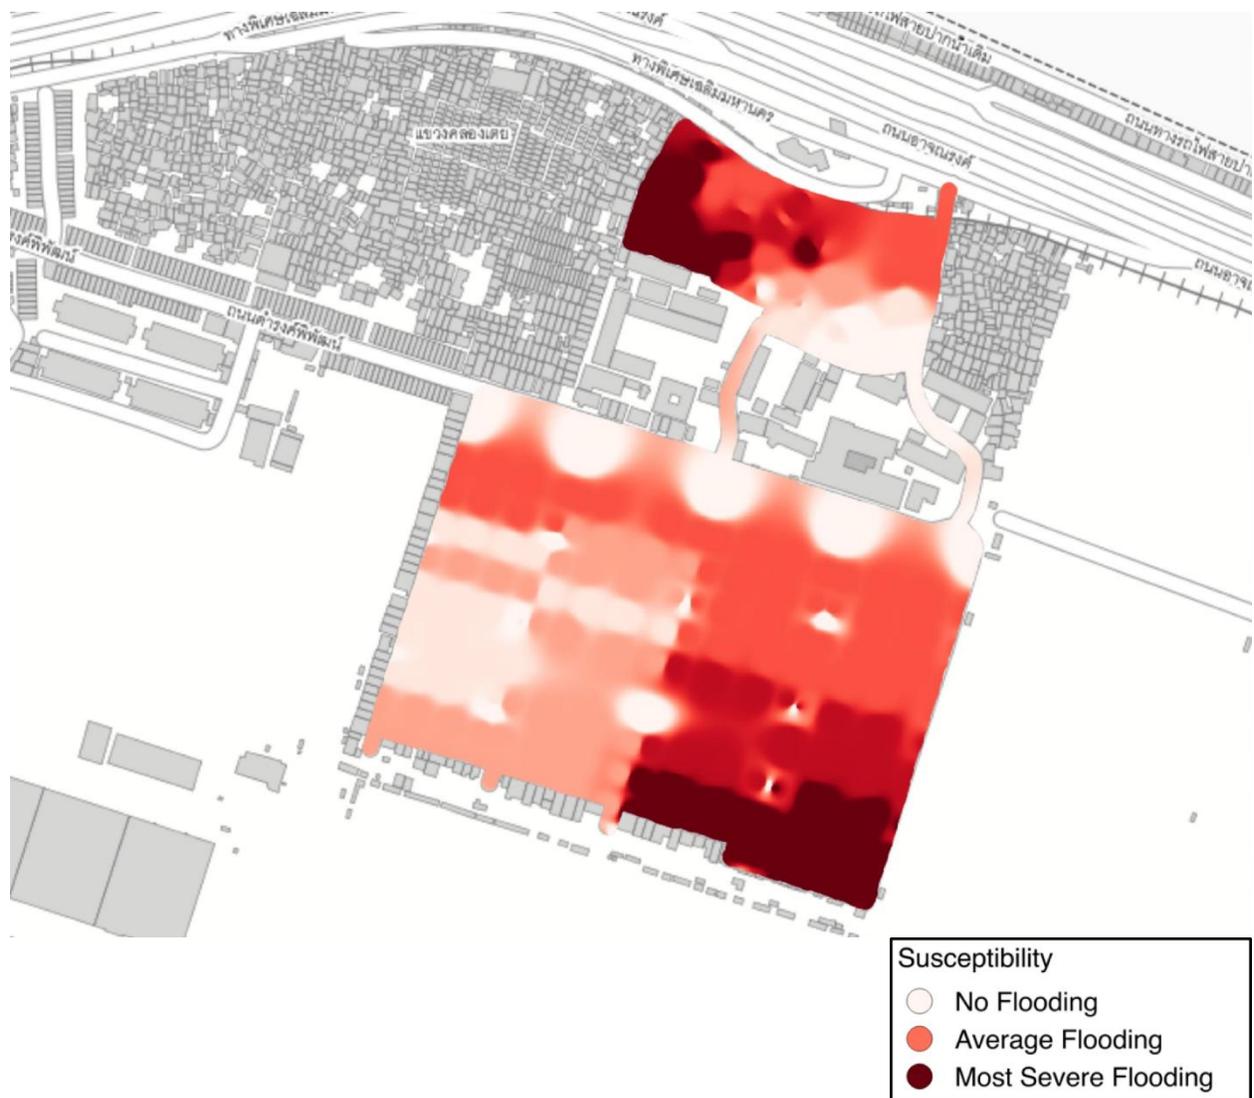
Map 1: Susceptibility

This map depicts locations that residents and community leaders have stated are more susceptible to flooding. The darker red represents the areas that are prone to the most severe flooding, while white shows the areas that do not flood. The areas that residents have said are the most vulnerable are the lower right area of 70 Rai, the left side of Lock 4, and the center of Lock 5.

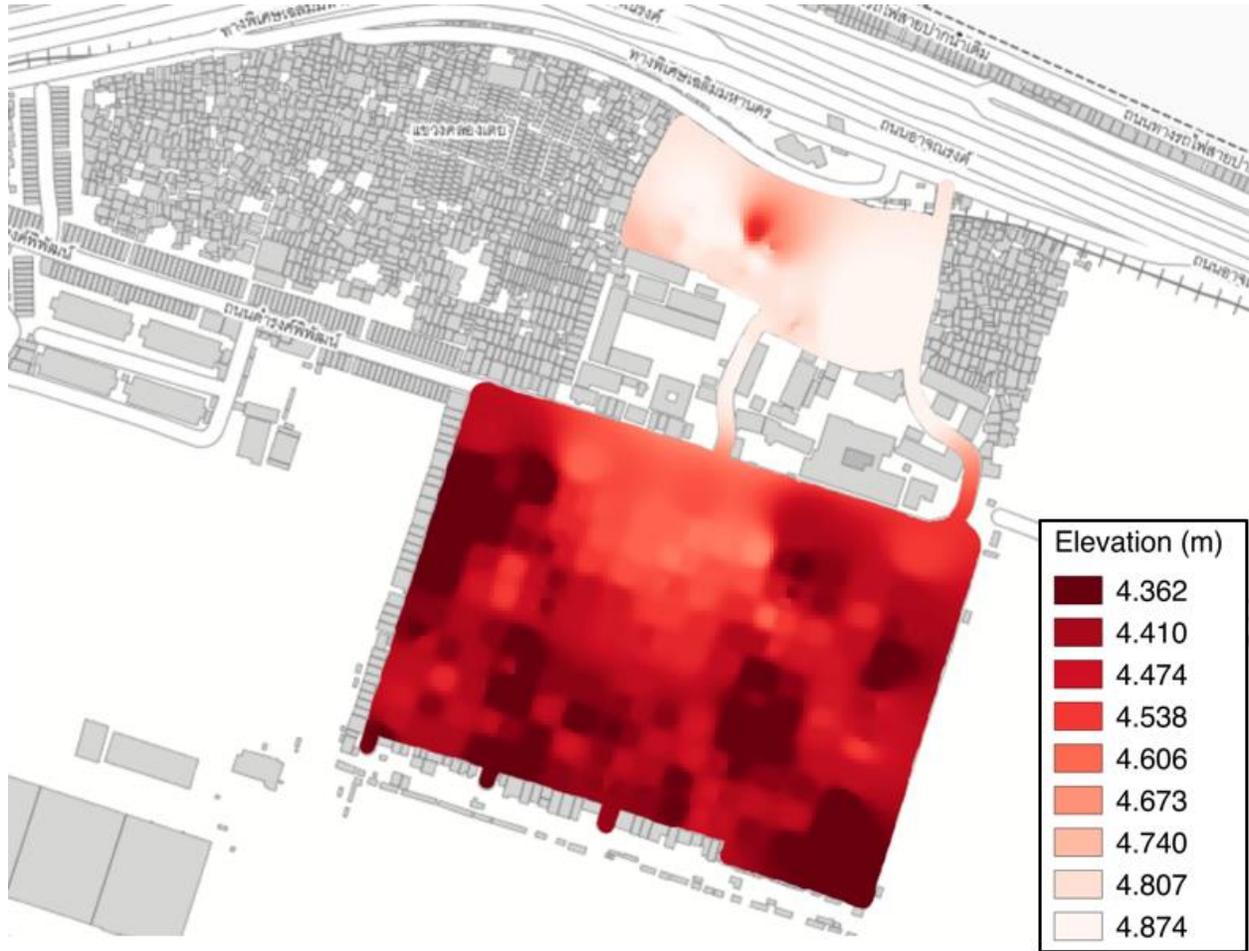
Map 2: Elevation of Lock 4-5-6 and 70 Rai

This map depicts the elevation of Khlong Toei. Elevation data points were gathered at multiple locations along the Sois using the Google Maps Elevation API. Lower lying areas are shown in darker red while the lighter areas are slightly higher. Lock 4-5-6 sits at a higher elevation than 70 Rai. Within 70 Rai, the elevation is higher in the North and lower in the South. The lowest elevation being in the canal located to the south of 70 Rai, towards the Southeast corner of 70 Rai. The areas that are lower is consistent with where the residents say the flooding is more severe. However, some other areas are low yet do not experience flooding. These reasons will be explained further in the report.

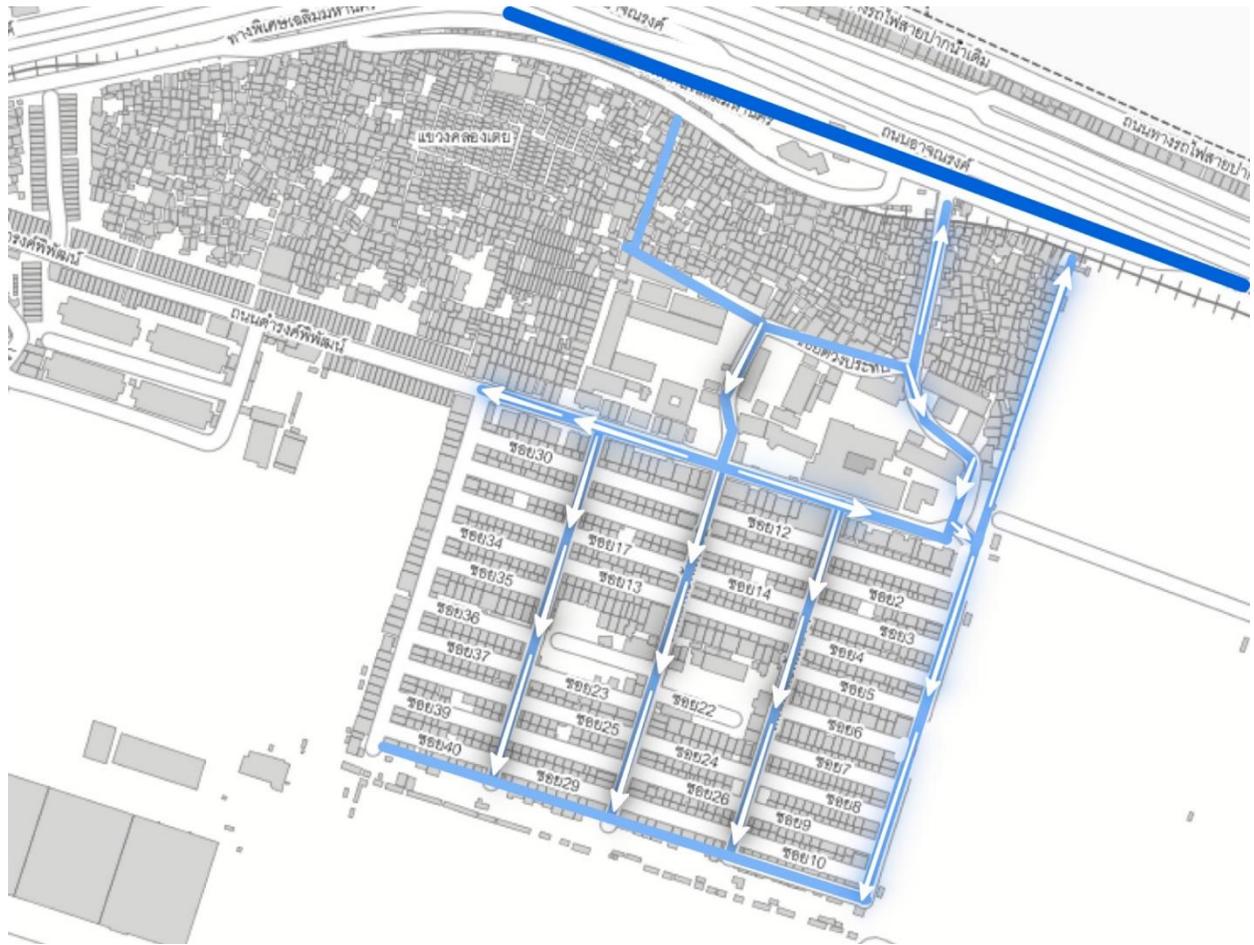
Map 5: Designed Water Flow

This map depicts the flow of water in the drainage system as it was designed. When we compare it to the elevation, it is clear that the system was designed for the water to flow downhill, from the top of 70 Rai to the canal at the bottom where the water is lead to the Chao Phraya River through pipes that go underneath the Port Authority.

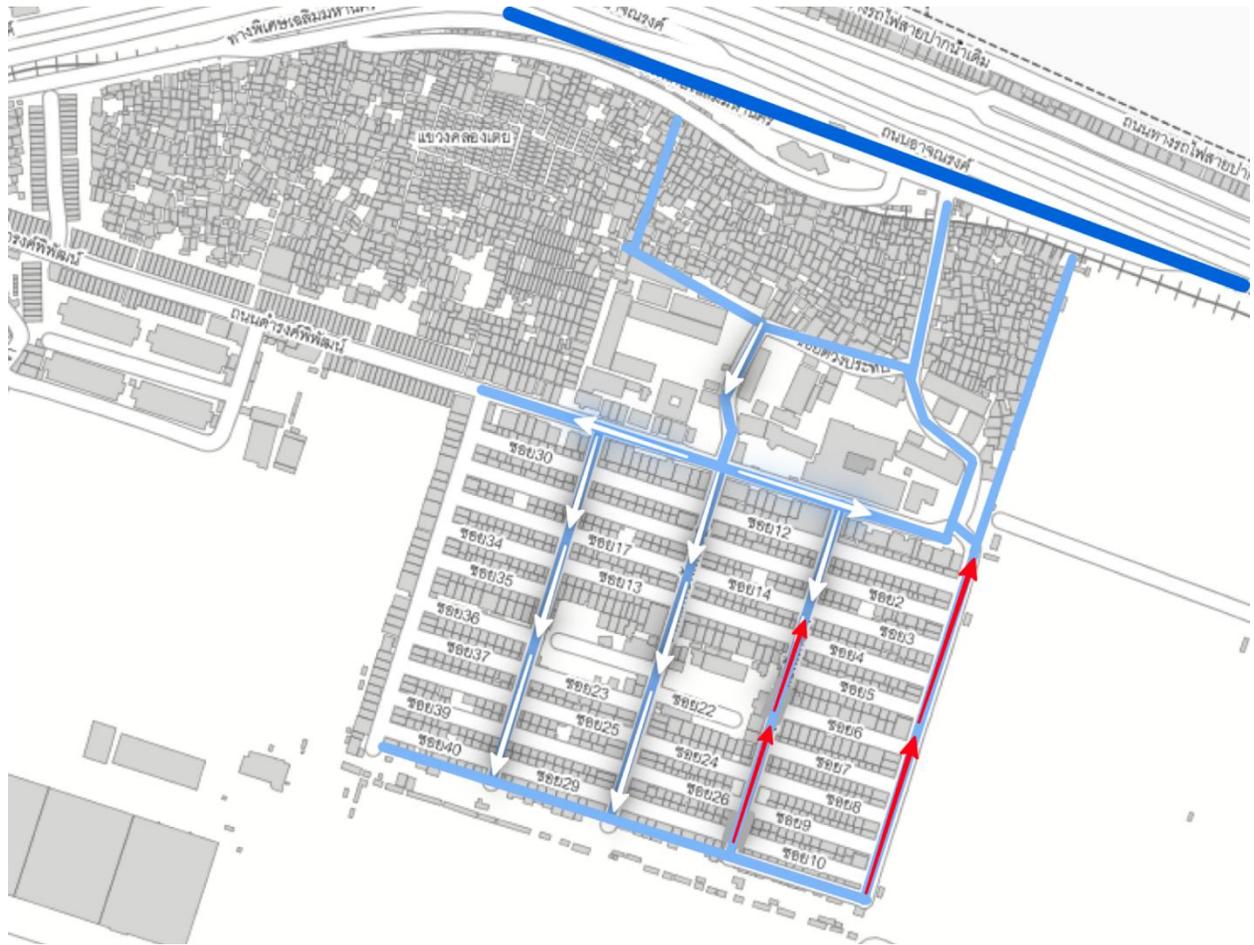
Map 6: Actual Water Flow

This map depicts the current state of water flow of the drainage system of Khlong Toei. Notice the majority of the drains are stagnant and some portions are flowing in the wrong direction represents in red arrows. This is the direction of water flow because the canal at the bottom of 70 Rai has nowhere to go, as the pipes leading to the Chao Phraya river that go underneath the Port Authority have been closed off with concrete. Because of this, the community made the drain on the right side of 70 Rai angled so that the water would naturally flow up 70 Rai. This is because the community must pump the water out of the drain to the Hua Lampong Canal, which is at a higher elevation.

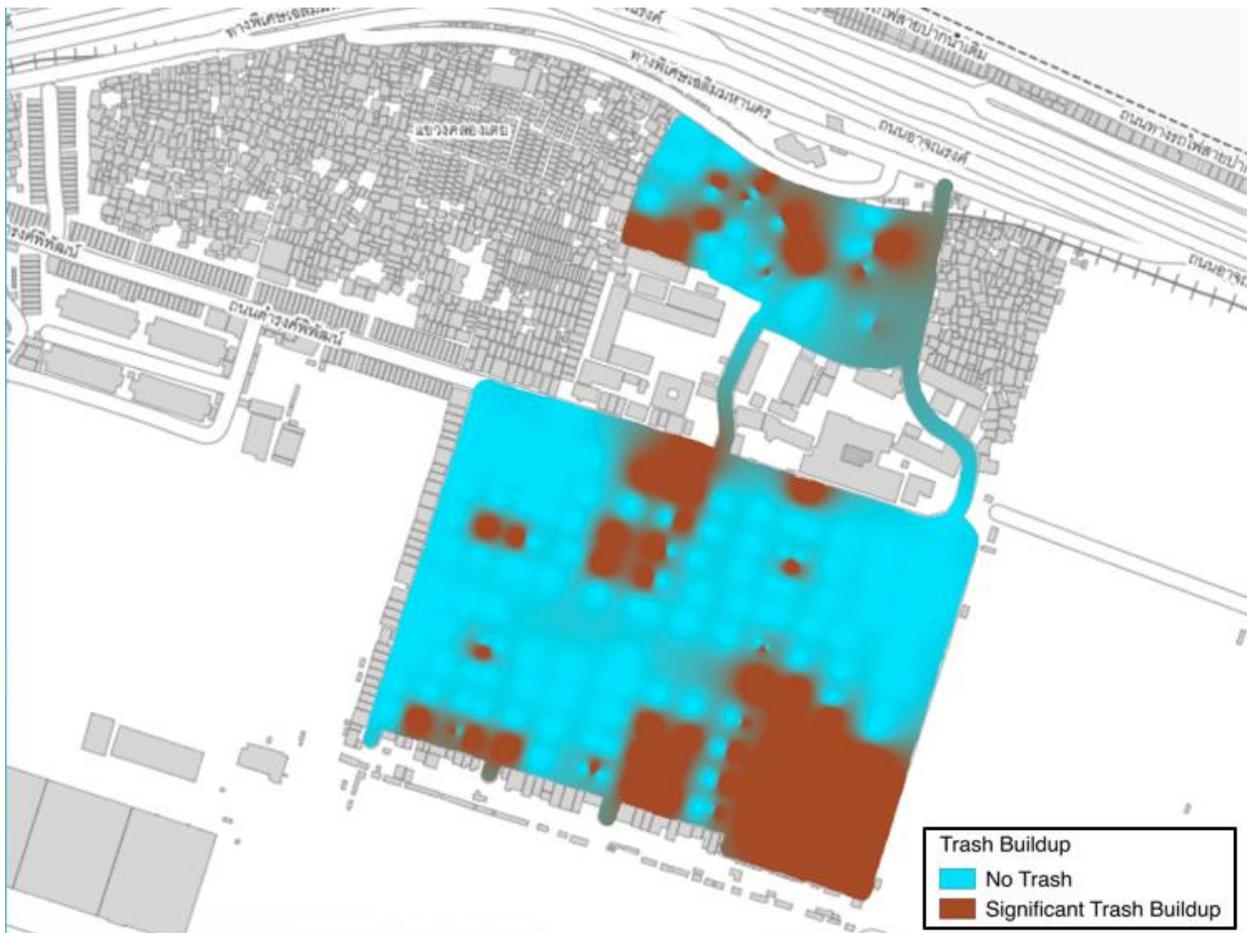
Map 7: Trash Buildup

This map depicts locations with excessive trash build up. The area in brown shows where trash has built up in the drains. Notable locations are the bottom right of 70 Rai, the canal in the center of 70 Rai, and the majority of Lock 4-5.

We observed a strong correlation between areas of prominent trash buildup (Appendix E) and areas reported to be most flood-prone by residents. Water flows to areas of lowest elevation, bringing with it trash and sediment, which contributes to clogging, which exacerbates flooding.

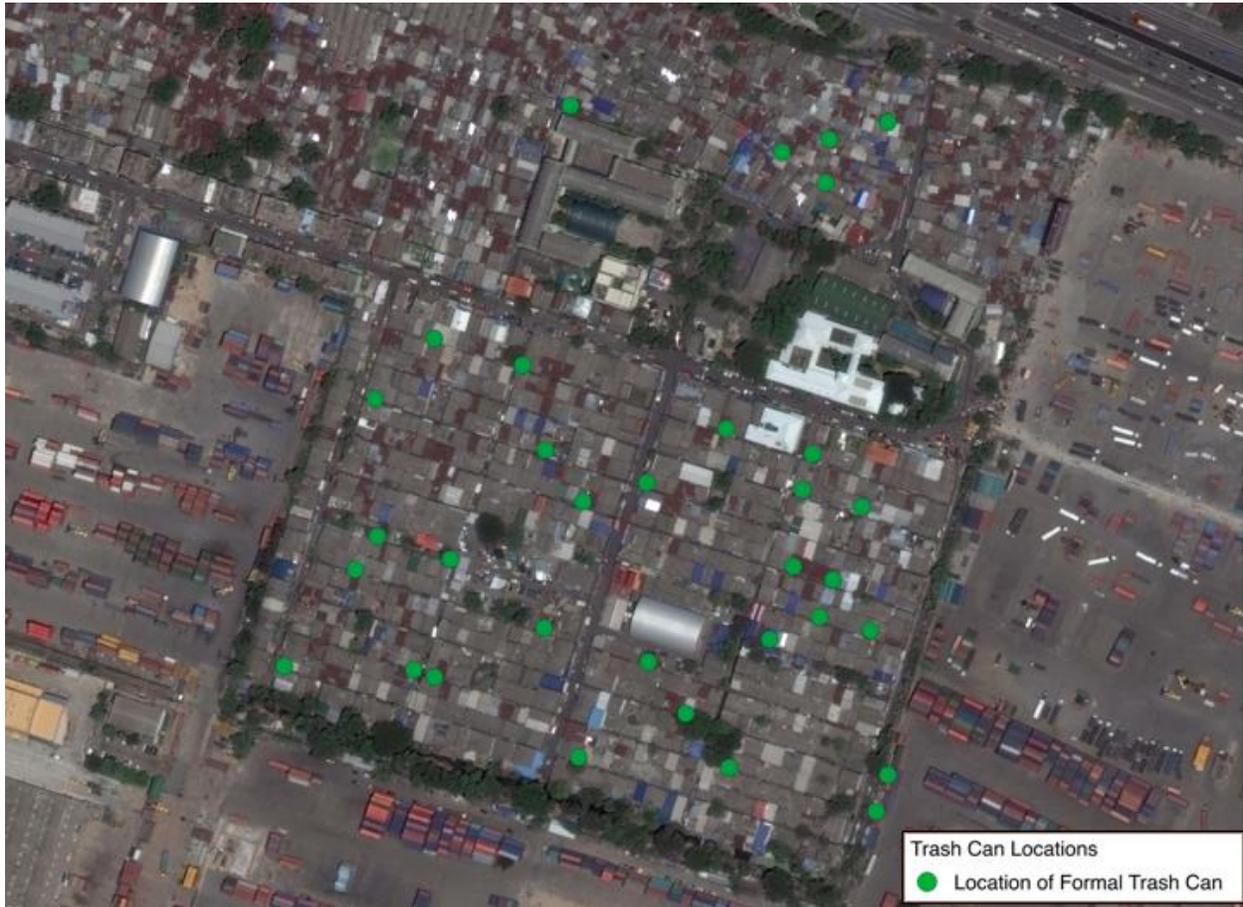
Map 8: Locations of Trash Bins

This is the location of the district trash bins we observed. The Khlong Toei District is responsible for emptying these trash bins, which are intended to be picked up daily. There are almost no formal trash bins in Lock 4-5 compared to 70 Rai, where the district trash bins are placed in front of most Sois. The only trash can in lock 4 is at the lower left area where all of the community trash is collected in a big wasteland.

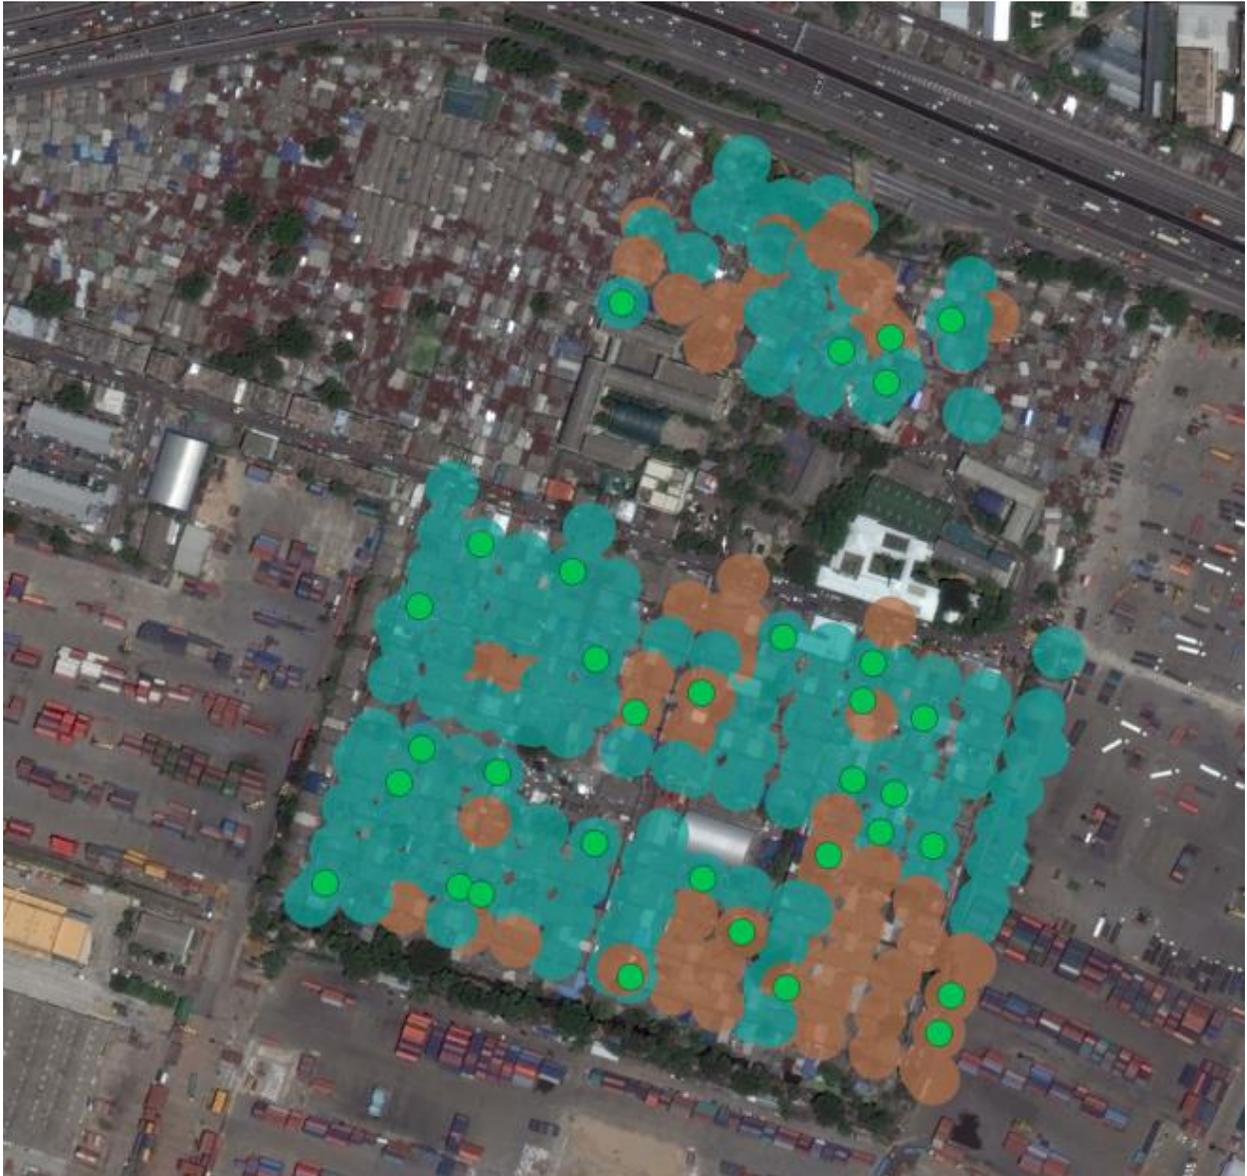
Map 9: Trash Bins on Trash Buildup

In this map, the locations of the trash bins are overlaid on the areas of trash buildup. The green dots represent the locations of the trash buildup. When we compared this map to the areas of significant trash buildup, we found that the areas that have trash bins are more prone to trash buildup. This is because residents throw their trash into the drain next to the trash can if the can is full. This simply becomes a trash area, and the waste ends up blocking the drains.

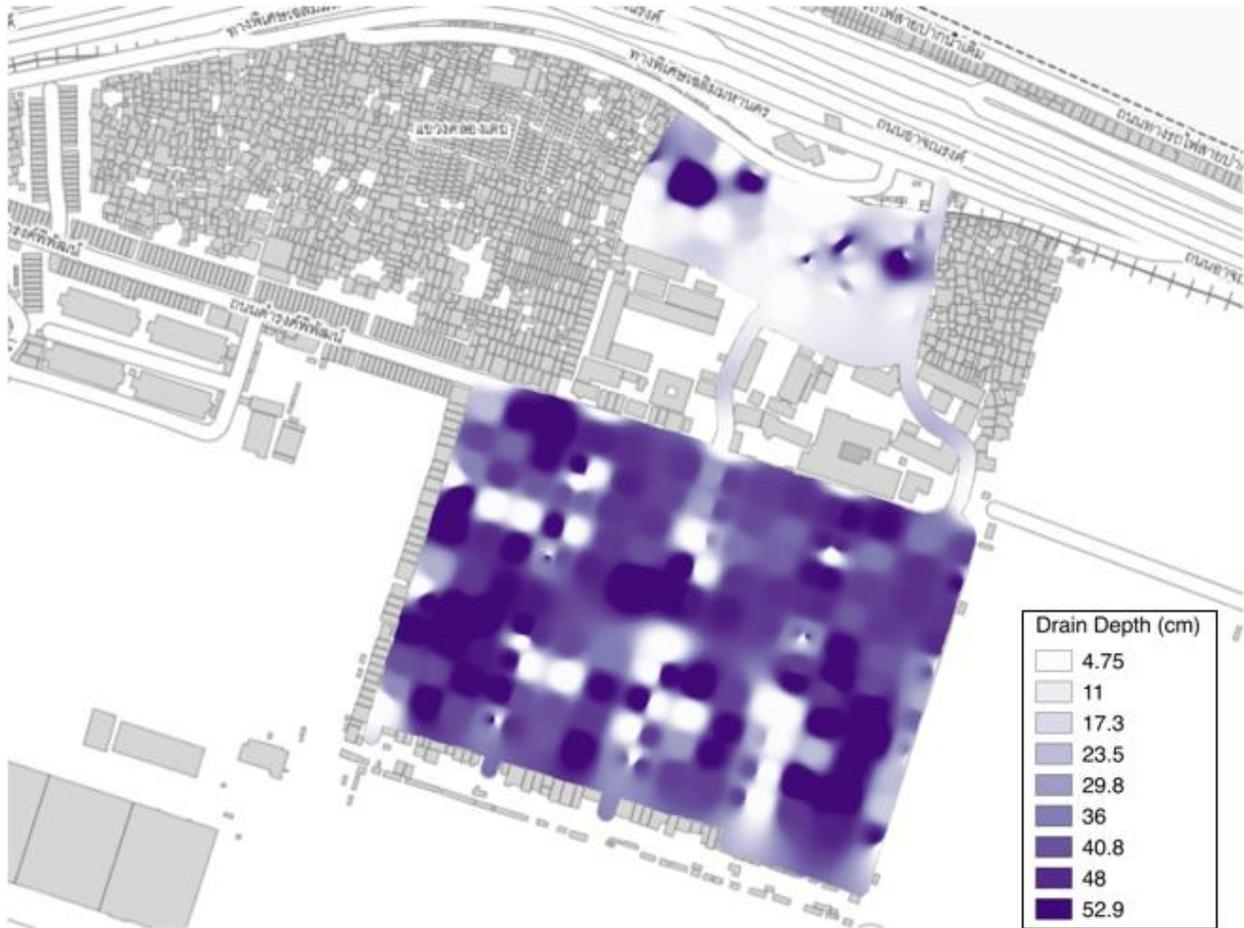
Map 10: Drain Depth

This map shows the depth of the drains in Lock 4-5-6 and 70 Rai. The dark purple represents the deeper drain, while the lighter colors show the shallower drains. When there is no drain then the value for the depth is marked as 0. Locks 4-5 do not have a formal drainage system while 70 Rai does. Any drainage system previously in Lock 4-5 has been covered and blocked by residents filling their land with concrete.

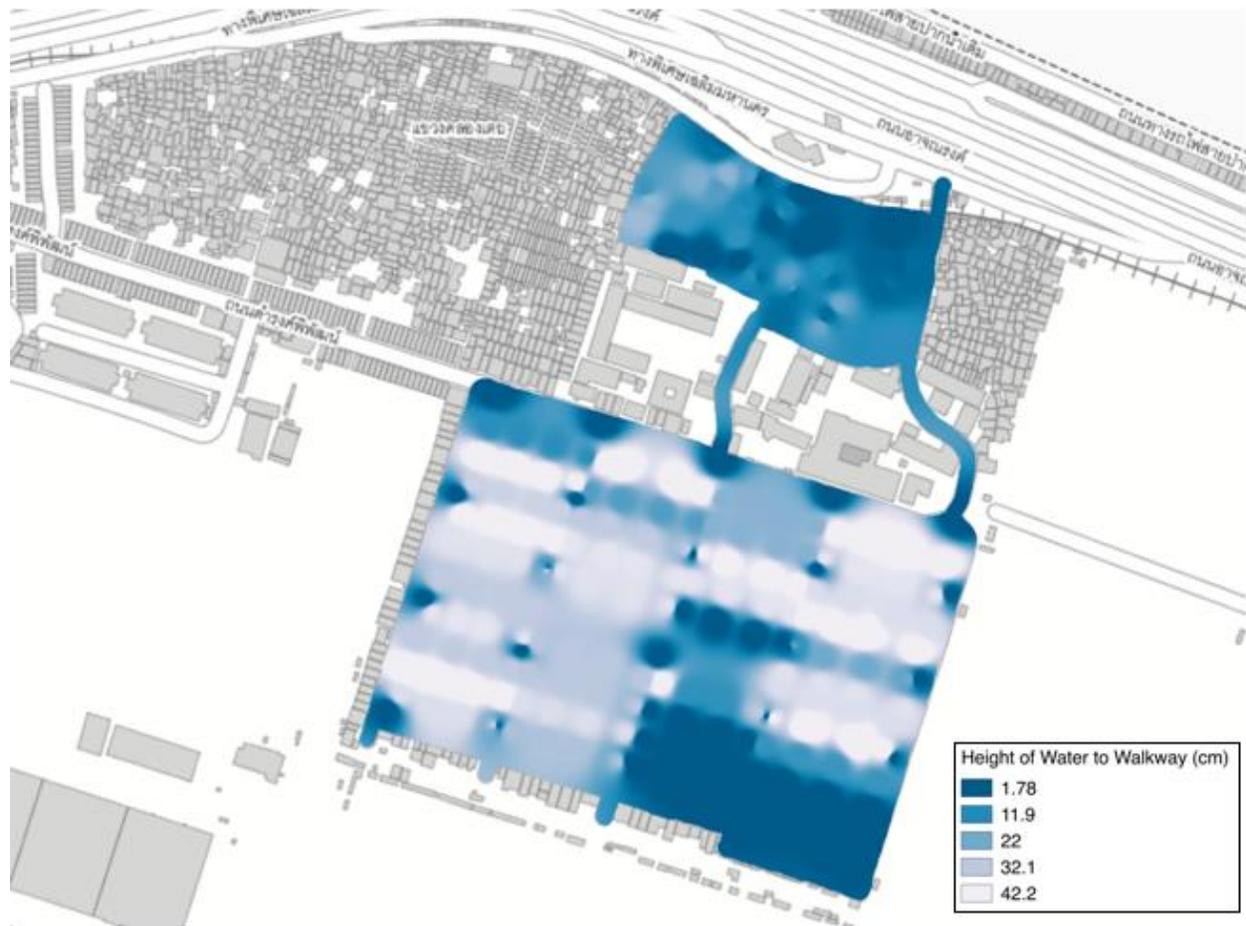
Map 11: Height from the Top of the Water to the Walkway

This map depicts the height of the water in the drains to the walkway on Jan. 26. Lower heights indicate locations that would flood first, as it shows the minimal amount of rainfall before the walkway would be covered in water. There are other factors that go into this, such as the water flowing from different areas due to elevation, and how effective the drains are for getting the water to flow out of the area. Lower heights may also indicate locations that may have high sediment or trash buildup, potentially going up all the way to the walkway.

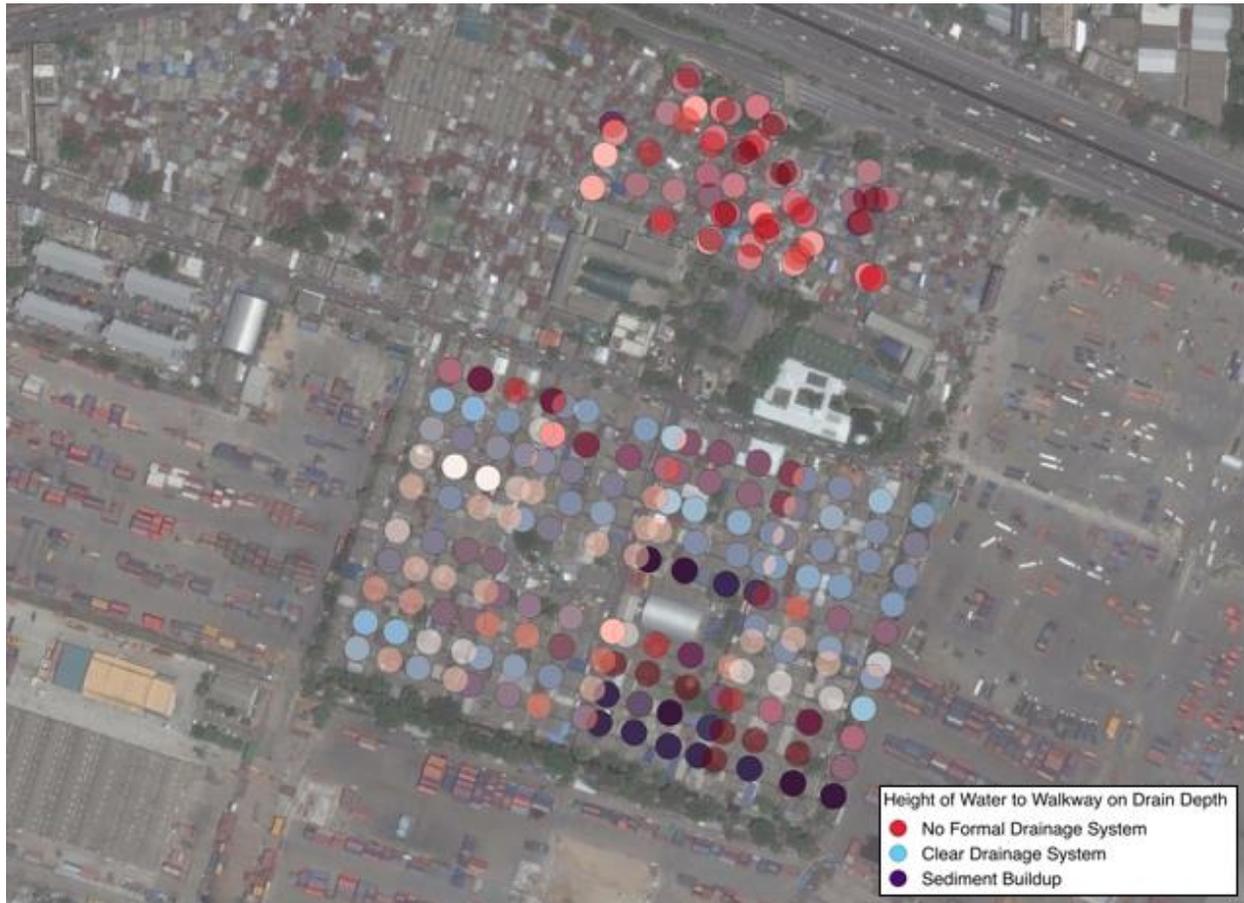
Map 12: Height of Water to Walkway on Drain Depth

This map shows the height from the water to the walkway overlaid on the depth of the drainage. By making the Height of the water to walkway red and partially transparent on top of the drain depth (blue), we can analyze the trends more easily. From this map we can determine two important findings. First, where there is purple it means that the drain is deep but the water is higher, indicating where there is sediment built up in the drain preventing water from flowing out of the Soi. We can also determine that where there is red means that there is no drainage system, as the drain depth is low, or zero, and the height to walkway is also low.
