พระราชนิเวศน์มฤคทายวัน
MRIGADAYAVAN PALACE
美麗閣夏宮

Identifying Viable Preservation Methods for Rust Corrosion and Fungi Deterioration in Wood and Concrete Structure and Developing a Monitoring System for the Conservation of the Mrigadayavan Palace

An Interactive Science and Social Project (ISSP) submitted to the Department of Chemistry, Faculty of Science at Chulalongkorn University, Thailand in partial fulfillment of the requirements for the Degree of Bachelor of Science in Applied Chemistry

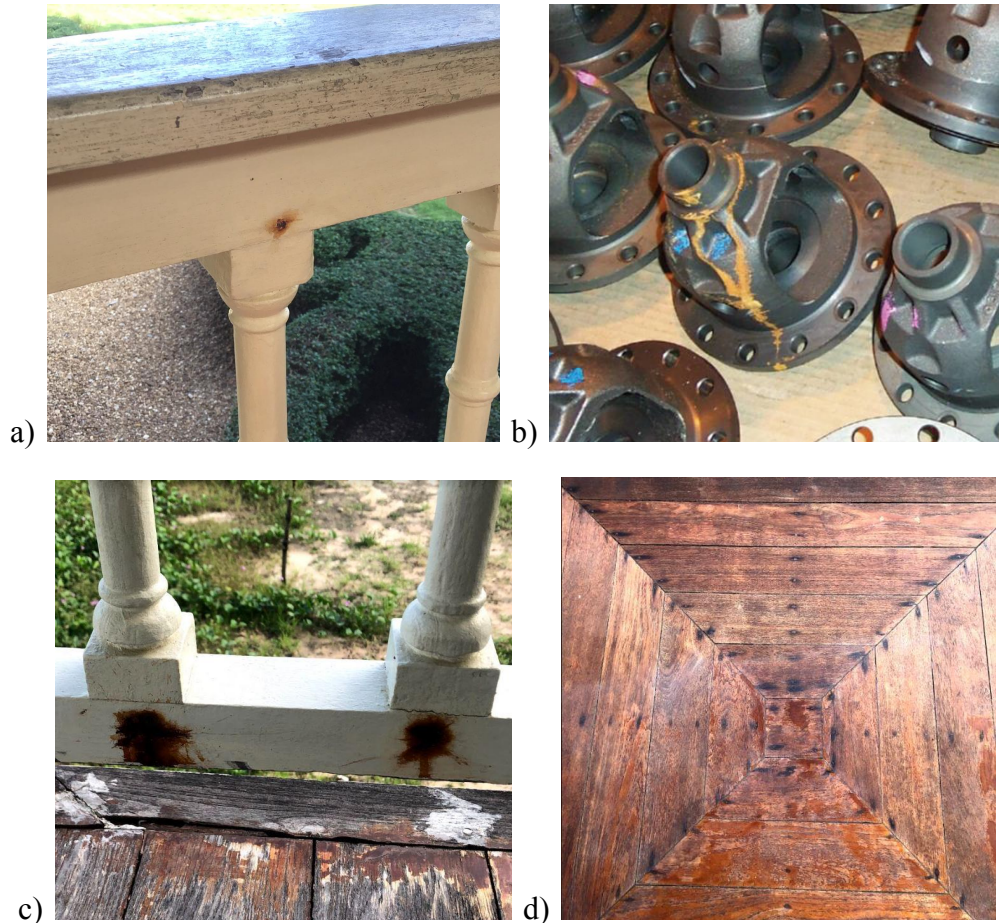
Brown rust, or iron(III) oxide (Fe_2O_3) (Figure 4c), is formed in conditions where there is high oxygen and low moisture. Lastly, Figure 4d displays black rust, or iron(II,III) oxide (Fe_3O_4), which can occur in areas of limited oxygen and low moisture content. This type of rust can be visually identified as a stain or a thin, black film. Compared to other types of rust mentioned, black rust does not propagate or corrode as rapidly as others.

Figure 4a. Photo of red rust. *Figure 4b.* Formation of yellow rust on metal parts. Reprinted from *Types of Rust* by Armour Protective Packaging. (2019). *Figure 4c.* Photo of brown rust. *Figure 4d.* Photo of black rust.

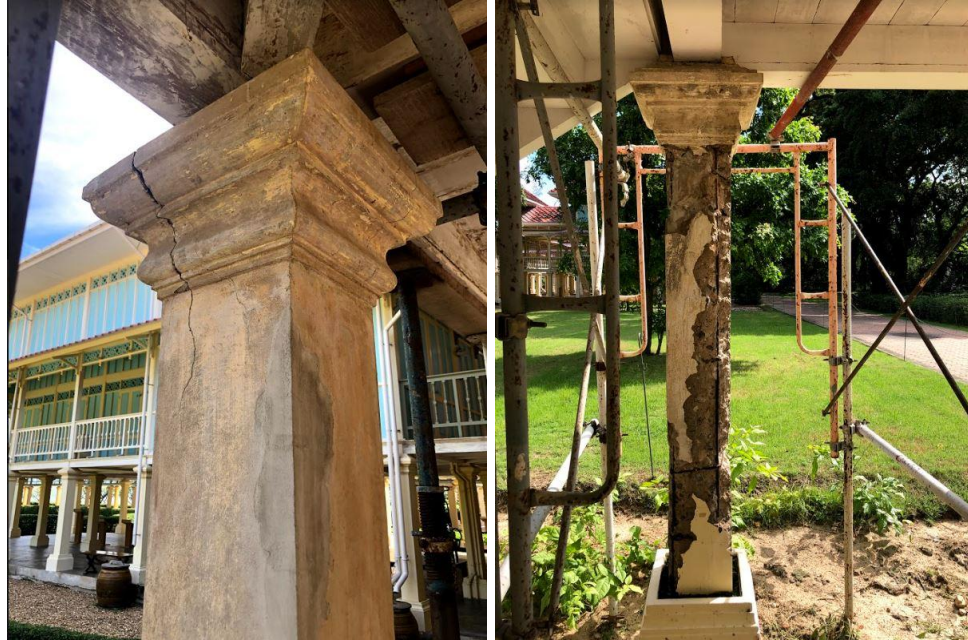
Currently, apart from the corrosion of metal nails in the wood, another major problem that the palace staff are concerned about is the corrosion of the reinforcing steel bars inside the concrete columns, which could further lead to the deterioration of the surrounding concrete itself. Signs that indicate the rusting of reinforcing steel bars are usually stains and cracks on the concrete surface. Once rusting of the internal steel bars happens, the internal steel bars will get thicker and their volume will increase, which leads to the expansion in size that will further create tensile stress within the concrete structure. As a result, this can eventually cause cracking, spalling, and deterioration of concrete (Portland Cement Association [PCA], n.d.).

Figure 5. Photo of cracking and spalling of concrete columns around the palace area.

To repair cracked concrete columns with rusted internal rebars, the team recommends replacing the internal rebars with epoxy-coated rebars to extend lifespan of the rebars. Fly ash or polymers can be added to the cement mix to form concrete that is less penetrative to gases and moisture, which are the causes of rust and corrosion. Additionally, the team recommends that the thickness of concrete covering the rebars should be at least 3 inches.

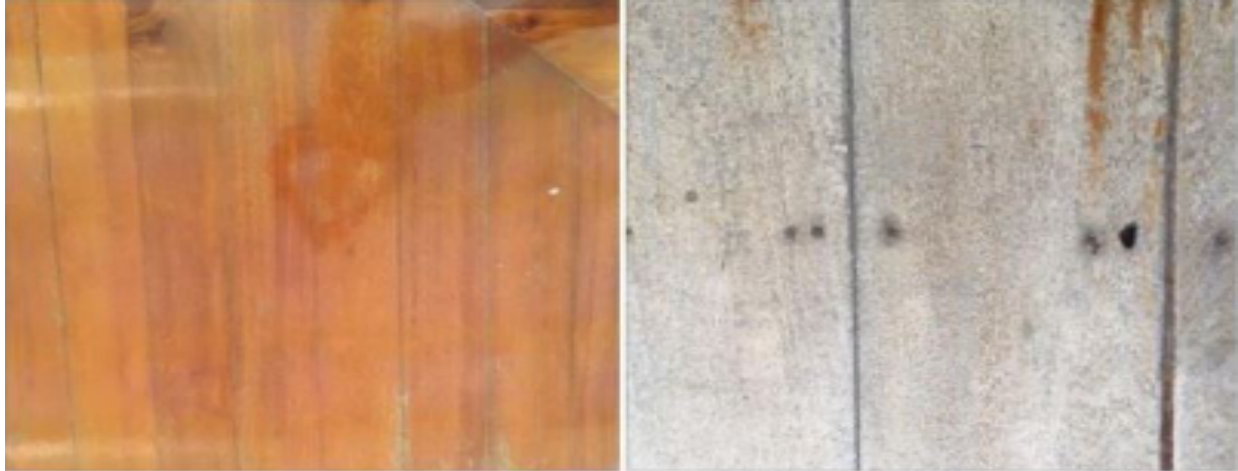
For the wooden floor at the palace, there is no presence of rust in the original structure because when the palace was first built, the nails were inserted inside the wooden planks, thus the nails were not exposed to oxygen, water, and chlorides. In a previous restoration attempt, when workers found wooden planks that started to stick out, they simply hammered those planks down with new nails, which are exposed to previously mentioned agents that can cause rust (Figure 12). Similarly, for the concrete columns (Figure 13), the original columns were made purely from concrete with no internal reinforcement bars. However after previous restoration, about 10% of the columns now contain internal rebars, and some of them are heavily deteriorated due to the corrosion of the reinforcing rebars inside. This indicates that restoration was not done correctly as well as the carelessness and lack of understanding towards the consequences of these restoration methods used.

Figure 11. Comparison of original wooden floor (left) and structure after previous restoration (right) of wooden floor. Reprinted from *The Restoration Management of Mrigadayavan Palace* by Sakunjaroenpornchai, P. (2017).

To deal with rust on iron nails, the team recommends removing the rust first and coating the nails with substances that prevent rust or a complete replacement with stainless steel nails. Alternatively, tannic acid can be directly applied on rust to prevent the metal underneath from further rusting. This method does not require cleaning or removing rust as tannic acid can convert rust surface into a protective layer, to help protect the nails and prolong rust in areas that are waiting to be repaired.

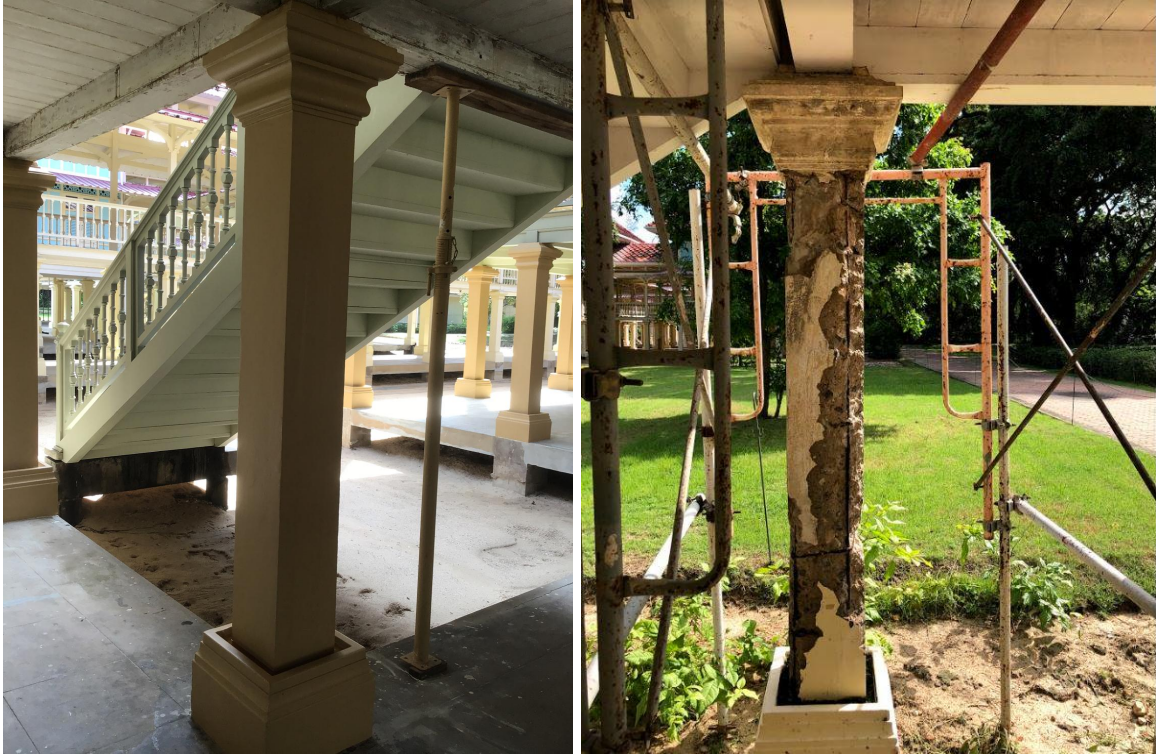
Figure 13. Photos of concrete columns without internal rebars (left) and with internal rebars that have rusted (right).

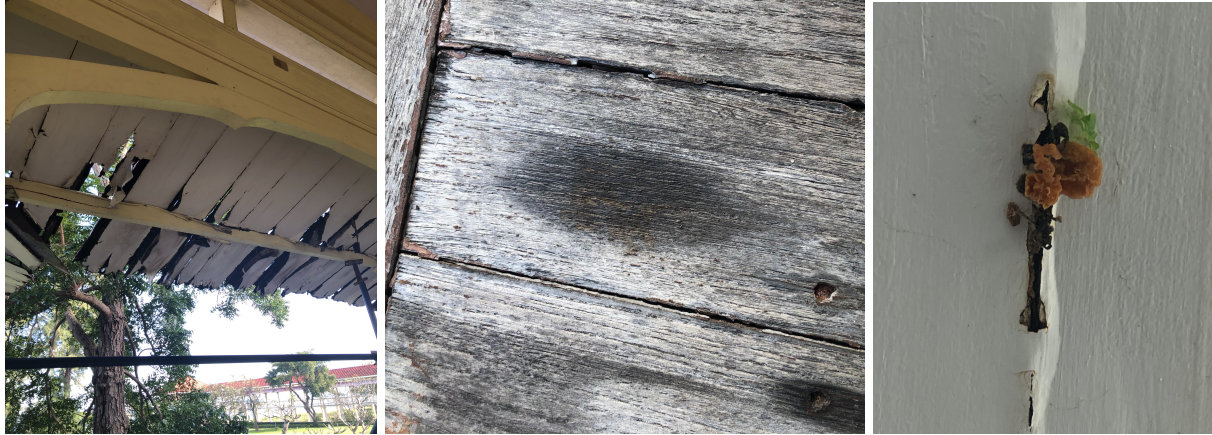
Our team observed the palace as well as talked with palace staff to see and understand the severity of the problem of fungi. We also looked through different research papers and interviewed an expert to discover the causes that could initiate the growth of fungi. We have understood that fungi is a decomposer that needs water and nutrition to grow. Since the palace is located on the seaside, the humidity from sea water is a major cause for high moisture content in wood. There are also many large trees around the palace, which can release humidity to nearby wooden planks. This causes the wood to absorb moisture, contributing to the growth of fungi (Figure 14). Additionally, puddles of water can also be seen on the palace floor (Figure 15), contributing to increased moisture in wood. Therefore, we can conclude that the wooden structure of the palace that contains high humidity content can act as a suitable nutrition source for fungi.

Figure 14. Photos of wet wood and the growth of fungi at Mrigadayavan Palace.

To remove fungi, products containing hypochlorite, such as bleach, or Dettol should be used. Afterwards, the wood should be kiln-dried in an oven to make sure that the inside of the wood is truly dry. Wood preservatives that the team recommends are copper chrome boron (CCB) for furniture and indoor use and micronized copper azole (MCA) for outdoor use to prevent fungal growth on the wood.

In order to eliminate this problem, wood has to be thoroughly dry. However, according to conversations with the palace staff, a proper method of drying wood is not performed. Wet wood is only left to air dry. After a few days, the surface of the wood may feel dry, but the inside of the wood still contains moisture. From the leftover moisture, fungi can eventually grow back. Therefore, it is important that the process and the conditions for drying wood are controlled, and according to an interview with an expert, the most efficient way to dry the wood is to dry wood in a kiln or oven.

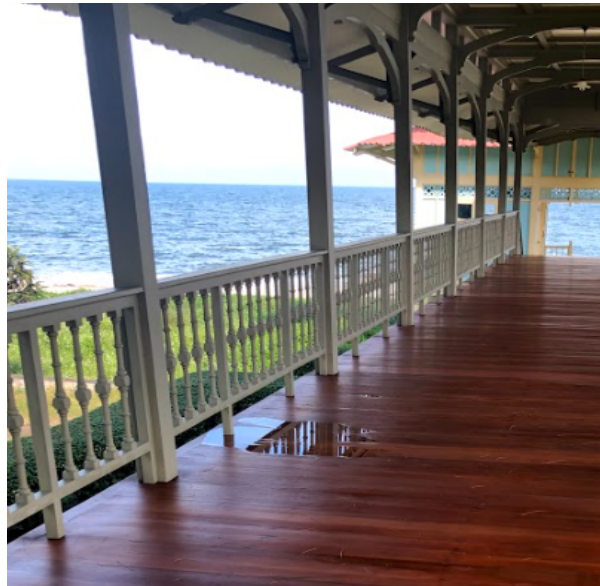
According to research and interviews with experts, wood should be dried thoroughly in order to avoid fungal growth on the wood. However, the presence of tall trees near wooden structures and puddles of water observed on the wooden floor around the palace

Figure 15. Photo of puddles of water on the palace floor.

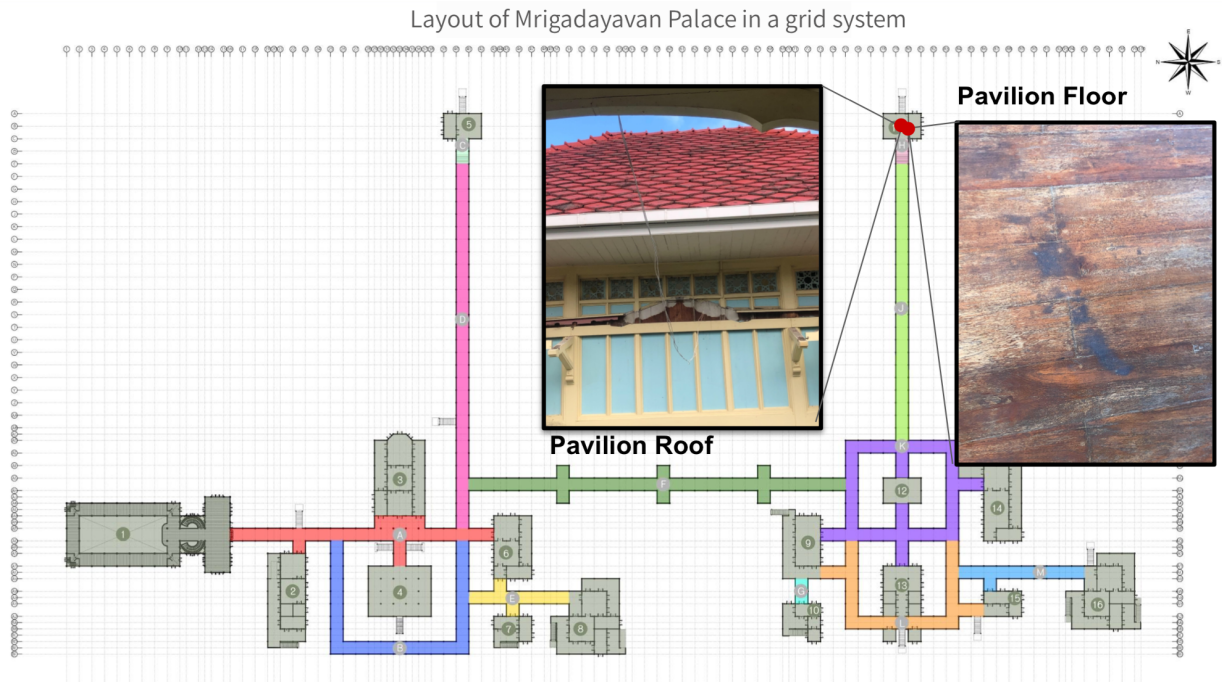
The pavilions are the closest structures to the ocean, right by the seaside, and structural damage to the roof of one of the pavilions can be seen. Black stains of fungi can also be seen to cover a large area of the pavilion floor.

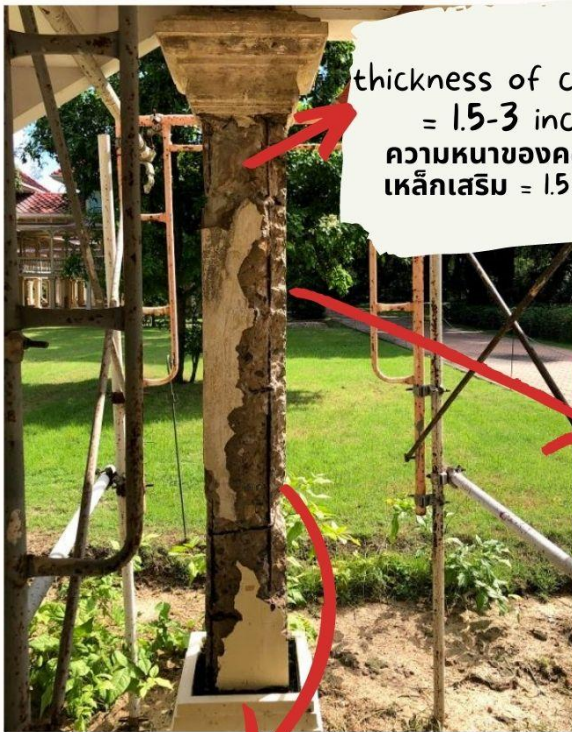
To prolong the deterioration of concrete columns:
เพื่อป้องกันการเสื่อมสภาพของเสาคอนกรีต

thickness of concrete = 1.5-3 inches
ความหนาของคอนกรีตหุ้มเหล็กเสริม = 1.5 - 3 นิ้ว

use concrete mixture ex. fly ash, polymer
ใช้สารผสมในคอนกรีต เช่น เถ้าลอย โพลีเมอร์
