Building Water Independence For Baan Sai Ngam Moo 13

Final Report Submitted on March 15, 2025

An Interactive Science and Social Project by:

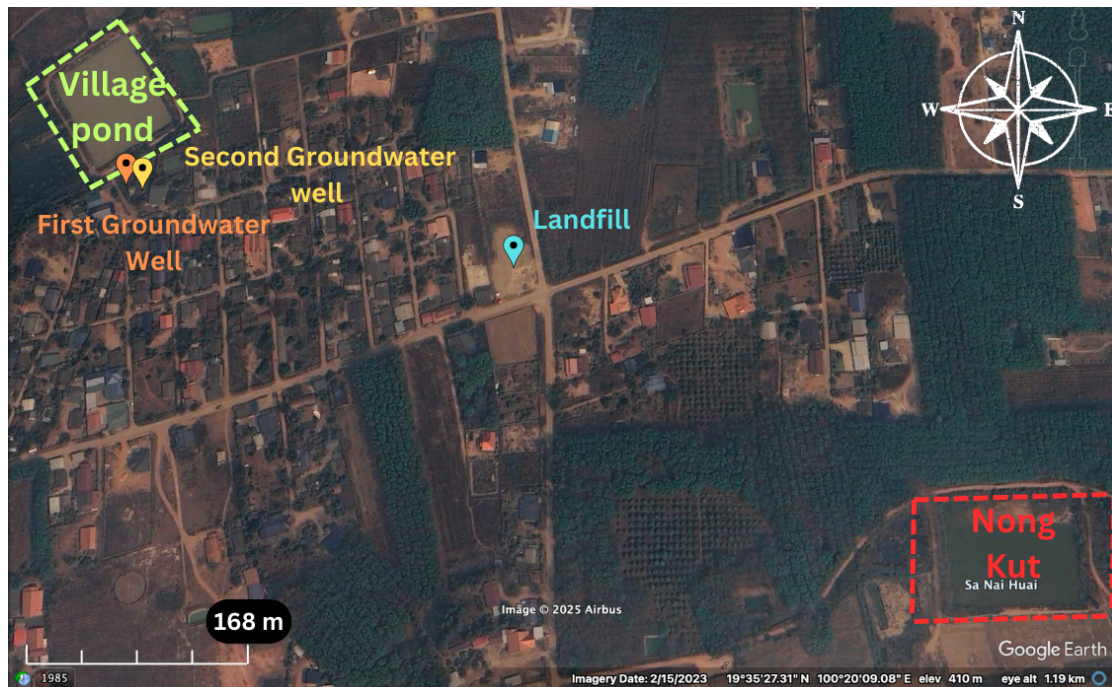
Figure 5. Location of Nong Kut

Nong Kut is a natural water source in Baan Sai Ngarm Moo 13 with 75m width, 120m length, 2m depth and a approximately 18,000 cubic meters water capacity storage (แบบเสนอโครงการของสถาบันส่งเสริมและพัฒนากิจกรรมปิดทองหลังพระสืบสานแนวพระราชดำริเพื่อเสนอขอรับการสนับสนุนงบประมาณจากกระทรวงมหาดไทย ประจำปีงบประมาณ พ.ศ. ๒๕๖๘, 2024). According to the water

management plan at the subdistrict level for Sop Bong Subdistrict, Ban Sai Ngam, Nong Kut efficiently enhances water supply management and increases water quantity for the community, especially during the dry season (แบบเสนอโครงการของสถาบันส่งเสริมและพัฒนากิจกรรมปิดทองหลังพระสืบสานแนวพระราชดำริเพื่อเสนอขอรับการสนับสนุนงบประมาณจากกระทรวงมหาดไทย ประจำปีงบประมาณ พ.ศ. ๒๕๖๘, 2024).

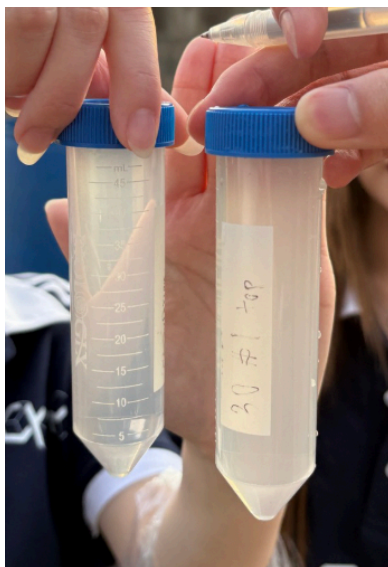
Figure 13. Water Samples Collected After Mixing with Alum (Left) and Raw Water (Right)

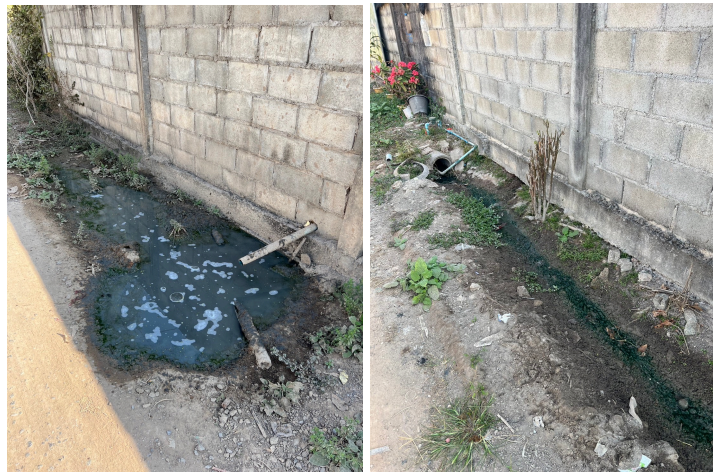
The households in Moo 13 do not have a proper wastewater treatment system, which leads to the direct disposal of greywater without adequate filtration or treatment. Some households store greywater in a soak pit, while most drain it through pipes into the streets (**Figure 17**). In both cases, the untreated greywater seeps into the soil, posing a risk of groundwater contamination (**Figure 16**).

Figure 16. The Drainage System Connected to the Road Outside of the House at One of the House in Baan Sai Ngam Moo 13

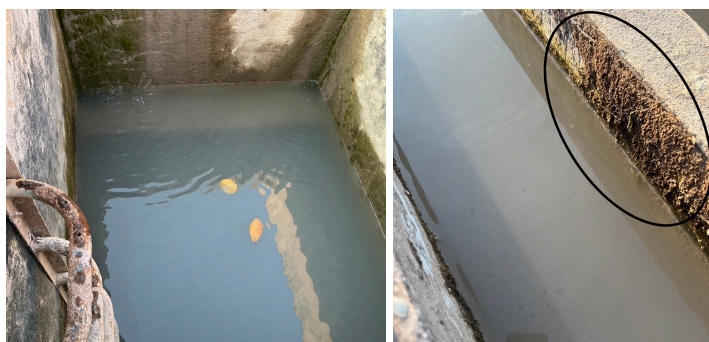
Observing the village tap water well and interviewing the village water caretaker, we found that they do not have a regular maintenance plan. The lack of routine system upkeep has led to the accumulation of debris and allowed external matters to remain in the flocculation system (**Figure 21**). On the other hand, Moo 5 and Moo 10 regularly follow a routine cleaning schedule for their water production system (**Figure 22**), which allows them to produce clean and clear water. This comparison suggests that irregular maintenance of tap water systems can potentially impact water quality, leading to potential contamination risks.

Figure 21. Moo 13's Surface Water Treatment System Contaminated with Leaves and Sediment Accumulated on the Wall (from left to right)

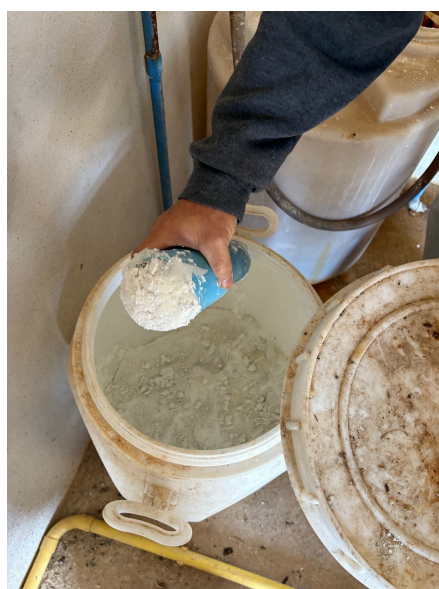
An interview with the caretaker of the tap water station in Moo 13 revealed that excessive chemicals are used to treat groundwater while the raw water quality was rarely inspected. Calcium hypochlorite, a disinfectant, is added visually instead of by precise measurement to match the quality of input water (**Figure 23**). The treatment process also uses alum to remove organic matter and certain heavy metals to clear the water. During the dry season, Moo 13 uses 375 kg of alum each month and 100 kg of alum each month during the rainy season or when the water has become more clear. While in both seasons, Moo 13 uses about 4.30 kg of calcium hypochlorite each month. These numbers are much higher than other villages like Moo 5 and Moo 10. Moo 5 uses only 1 kg of alum and two tablespoons of calcium hypochlorite, while Moo 10 uses 30 kg of alum and none of the calcium hypochlorite per month (**Table 5**).

Figure 23. Inconsistent Quantity of Added NaOCl

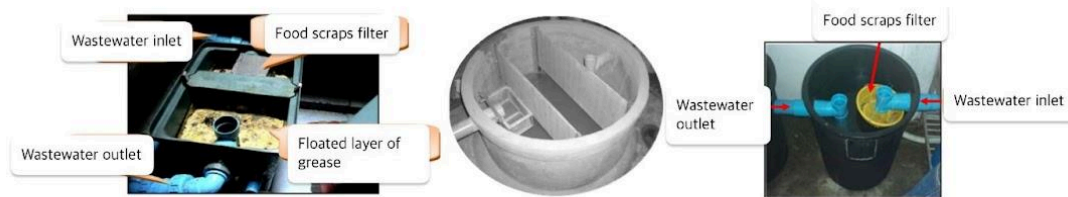
of the water to prevent the sludge from being distributed and short-circuited. The tank also required a gas vent pipe to release the gas produced (คู่มือการจัดการน้ำเสียสำหรับบ้านเรือน, 2020). These are the fundamental processes of treating wastewater from the kitchen before entering the wastewater disposal system.

Figure 29. Aqua Grease Trap Ready-to-use, Concrete-built, and Homemade from Left to Right (คู่มือการจัดการน้ำเสียสำหรับบ้านเรือน, 2020)

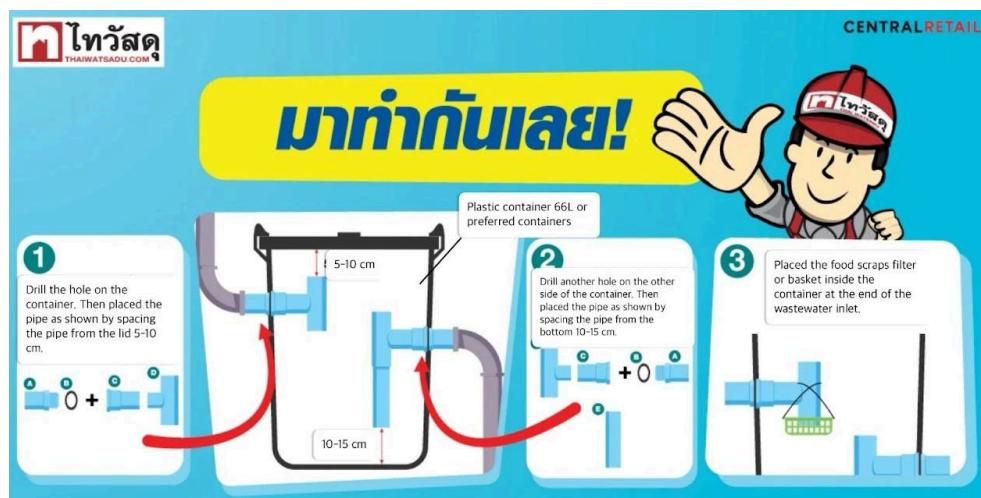
Figure 30. Self-made Aqua Grease Trap (Thaiwatsadu.com)

The wastewater treatment system process can be varied depending on the type of wastewater, consisting of wastewater from the kitchen, bathing and laundry, and toilet. In order to treat the wastewater from the kitchen, the wastewater must pass through a screen or basket to discard food scraps before passing through an aqua grease trap to collect the grease and oils from the kitchen. Not only does it help the pipe to be clogged-free, but it also prevents the grease from entering the sewerage or seeping into the ground. Different types of grease traps share the same system; they only differ in the material used (**Figure 29**). The wastewater from the kitchen sink comes through the inlet, which needs to pass through the food scrap filter. The water then gets stored in the tank, while the grease layer will eventually float on top of the water due to the lower density. The water outlet must be lower than the inlet ones to let the wastewater separated from the grease flow out. **Figure 30**. demonstrates the steps for the homemade aqua grease trap. If there is a large quantity of food waste or fat residue, the wastewater may go through a septic tank for further treatment. The septic tank is a pit installed underground for storing waste and wastewater (**Figure 31**). The purpose of the septic tank is to treat organic substances, preventing grease and settleable solids from flowing out the next treatment process. The septic tank is a sealed pit that relies on anaerobic bacteria to decompose the organic matter in the wastewater and produce gases, water, and sludge. Therefore, the flow of the water in the septic tank is designed to pass through baffles or pipes to slow down the velocity

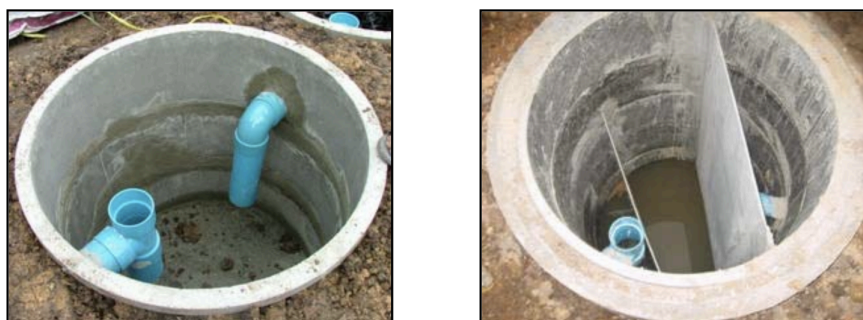
Figure 31. Septic Tank without Partition Wall and with Partition Wall (คู่มือการจัดการน้ำเสียสำหรับบ้านเรือน, 2020)

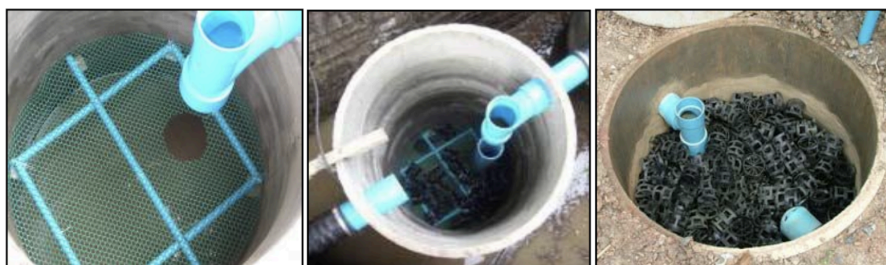
Treating wastewater from the toilet starts directly with the septic tank, where solids, such as feces, toilet paper and other impurities are settled on the bottom while fats float to the top. The anaerobic bacteria in the septic tank decomposed organic matter, with similar processes mentioned in the treatment of wastewater from the kitchen. Then the water passes through either an aerated or anaerobic treatment tank. This tank contains a filtering medium (media layer) to which microorganisms used to cling themselves. The wastewater flows into the bottom of the tank and then rises through the media layer, eventually flowing through the pipe to the top. As the water passes through the media layer, anaerobic microorganisms decompose organic matter in the wastewater, convert it into gas and water, and reduce BOD in wastewater. In order to increase the effectiveness of an anaerobic treatment tank, the distribution of microorganisms must be evenly throughout the tank. The treated wastewater then flows to the polishing unit, which separates any suspended microbial sludge for further water quality adjusting before discharged (คู่มือการจัดการน้ำเสียสำหรับบ้านเรือน, 2020). Similarly, wastewater from bathing and laundry flows through the septic tank to remove organic substances and filter through an anaerobic tank (คู่มือการจัดการน้ำเสียสำหรับบ้านเรือน, 2020).

Figure 32. Anaerobic Treatment Tank (คู่มือการจัดการน้ำเสียสำหรับบ้านเรือน, 2020)
