# Restoring Mrigadayavan Palace:

## Understanding Causes of Concrete Deterioration and Determining Viable Concrete Rehabilitation Methods

The Mrigadayavan Palace in Cha-am, Thailand has faced the effects of deterioration on concrete structures. The project goal was to preserve and rehabilitate the damaged concrete by exploring various concrete restoration techniques and determining viable methods, as requested by the Mrigadayavan Palace Foundation, to complete a restoration project for the palace's 100th anniversary in 2024. Throughout the project, information was collected through observations, fieldwork, and research. Recommendations to address the deteriorating concrete structures came in the form of a decision tree with extensive criteria for evaluating and determining which techniques achieved the desired outcome. Additionally, web pages, QR codes, and pamphlets were produced as educational materials for visitors.

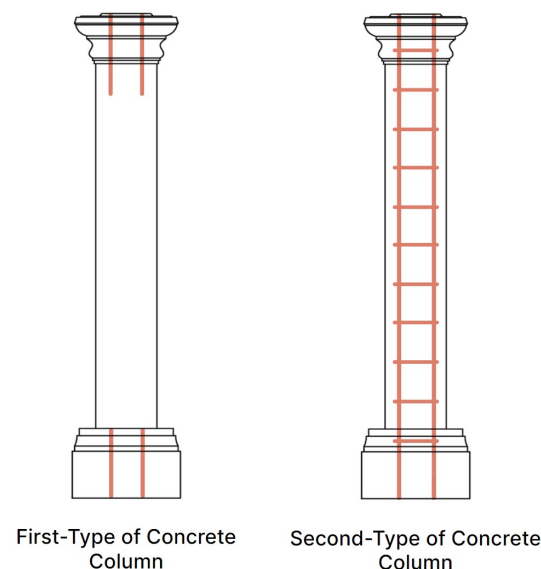
Figure 12. Illustration differentiating the first and second type of concrete columns

Palace. The first type is columns that have steel reinforcement only at the top and base of the column. The second type of column is columns that have steel reinforcement throughout the body of the column. The original type of concrete columns designed for the Palace by the original architect is the first type. However, later renovation efforts preferred the second type. An illustration differentiating the first type and second type of concrete columns can be seen in *Figure 12*.

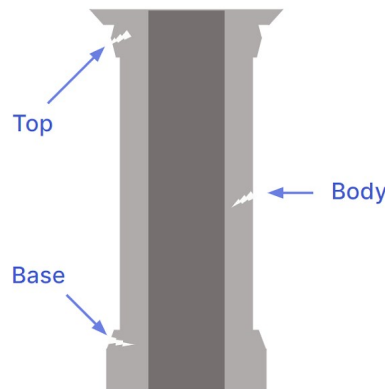
Figure 14. (left) Pattern of cracks on concrete columns, (right) location of cracks on

For the characterization of cracks in concrete columns, two primary patterns of cracks were observed in the sampling areas: vertical cracks and horizontal cracks. Cracks could also form on three different locations of the concrete column. These three locations include the base, body, and top of the concrete column. An illustration that shows the locations of cracks more clearly can be seen in *Figure 14*.

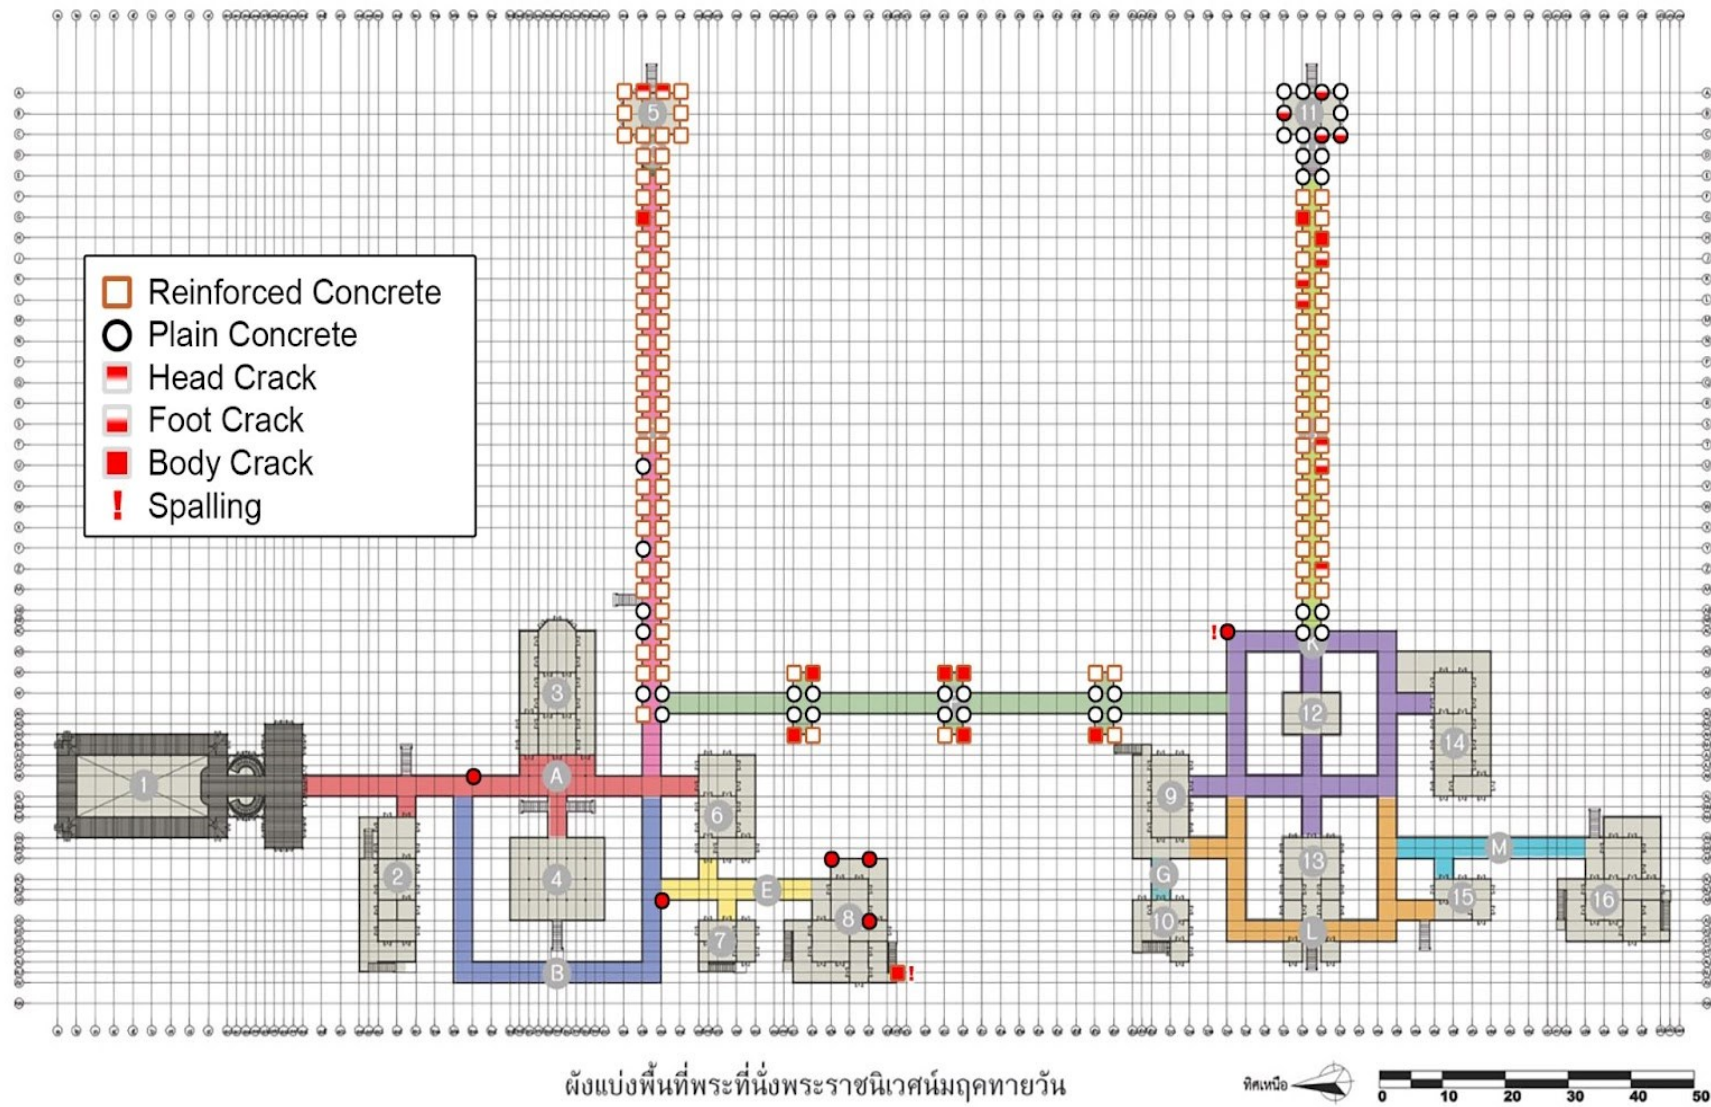
Figure 15. Illustrations of the collected data from the methodology

The illustration in *Figure 15* is the result of the sampling methodology from the first objective which is analyzing the effect of external factors on concrete columns through the use of the metal detector and qualitative analysis. The focused sampling area can be seen in the red boxes. The illustrations contain many different symbols that refer to different types of observations. The legends of the symbol can be seen in the white box on the bottom part of the illustrations.

Based on the information that the team collected, the team observed that the concrete columns that have steel reinforcement throughout the column seem to face a more severe degree of corrosion. This effect can be seen in *Figure 15*, *16*, and *17*. In *Figure 15*, which is of area one, only concrete columns that have steel reinforcement throughout the body had cracks in

them. In *Figure 16*, which is of area two, all of the concrete columns that experience cracks in them are also columns that have steel reinforcement throughout the body as well. In *Figure 17*, which is of area three, the number of columns that have cracks was twice as much for the columns that have steel reinforcement throughout the body. This evidence, therefore, supports the hypothesis that humidity and ocean sea spray have increased the affects of steel rebar corrosion.

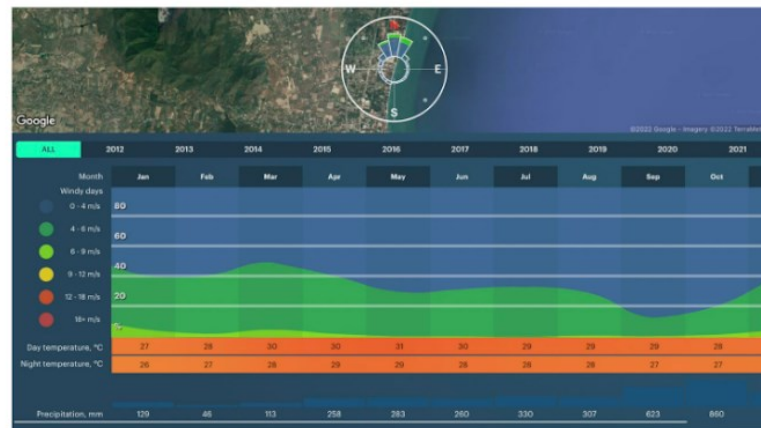
Figure 19. Detailed graph on Direction and Speed of Wind

According to the “Windy” application, with the specific setting that is mentioned in the wind assessment section in objective one, the wind flows into the Palace from the shore majority of the time. An average from 2012-2021 showed that eight out of the twelve months of the year, the wind’s direction flows directly into the Palace from either the north or the south as seen in Figure 19. Only 4 of those months

showed that the wind flows in the opposite direction, which is away from the Palace. Another important finding is that the speed of the wind is also the strongest during those eight out of twelve months. Detailed graphs that contain the direction and speed of the wind with further detail can be found in *Supplementary Materials E*. This correlates with the observation that the horizontal cracks were found on the opposite side of the column that faces the shore because the prevailing winds would be able to add an additional lateral load on the concrete columns. Since the majority of the wind flows into the direction of the Palace from one side, the lateral load would be added on only one side of the Palace. Tension would be increased from only one side of the column and the other side of the column would experience a decrease of tension. The side that receives the increase in tension would be the side that forms the horizontal cracks.

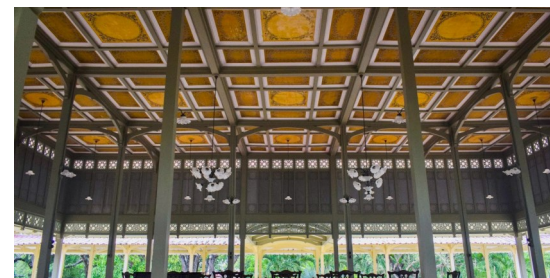
Figure 24. Photo of King's Dining Pavilion at the Mrigadayavan Palace

Other than the deterioration in the concrete walkways and columns, cracks and discoloration were also observed in the concrete ceiling panels. These concrete ceiling panels are found above every wooden walkway in the Palace. The panel placement in one area of the Palace can be seen in *Figure 24*.
