"Assessing the Impact of Human Activity on the Groundwater at the Mrigadayavan Palace in Cha Am, Thailand"

An Interactive Qualifying Project Report and Interactive Science and Social Project

Submitted On: March 6th, 2020

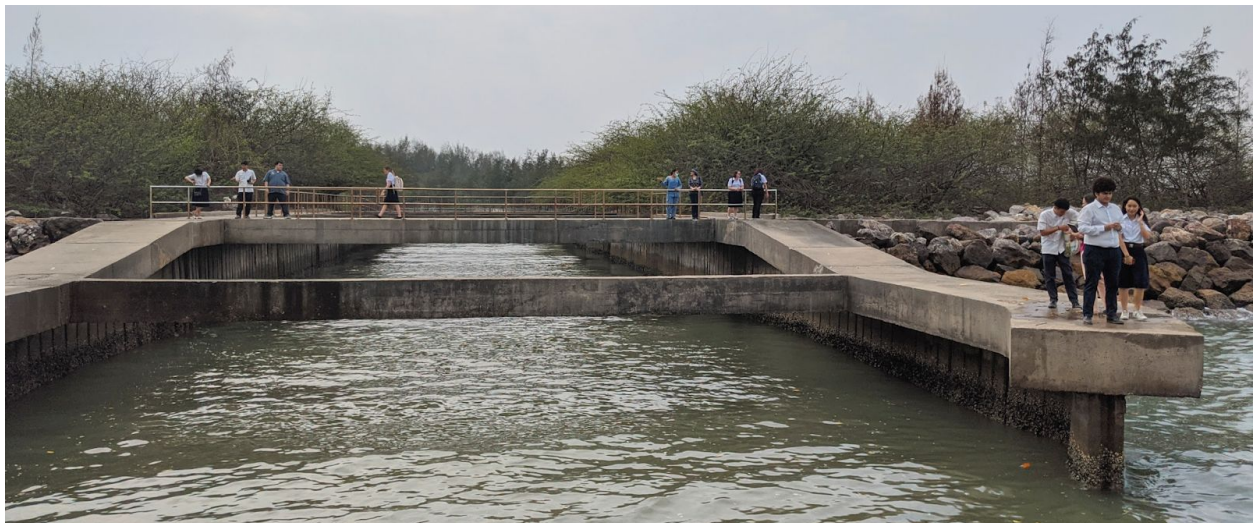
Figure 2: Photo of North Jetty

According to the Surfrider Foundation, jetties are structures that are built on the sides of a coastal inlet from piles of rocks or concrete. Typically they are meant to stabilize the location of the mouth of a river or stream from moving, however they can also be used to keep bodies of water open for navigation. There are two jetties constructed on the Mrigadayavan Palace grounds: one located to the North of the Palace and the other located to the South. While jetties can be beneficial, they can negatively change longshore currents, and tend to create an updrift and a downdrift beaches on either side. Furthermore, jetties can cause permanent damage to the equilibrium of beaches, affecting tidal circulation and wetland health.

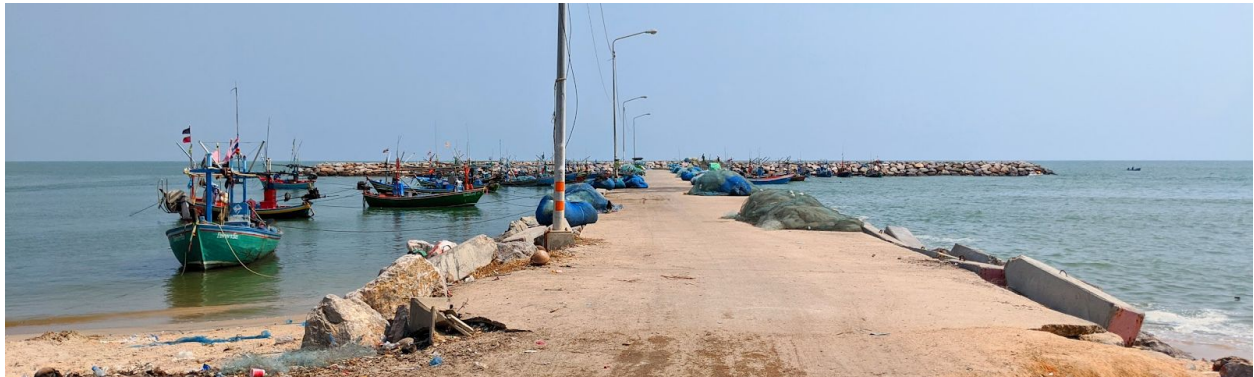
Figure 3: Photo of Groyne Meeting a Breakwater in Front of the Bang Kwai Community

Erosion prevention structures can include seawalls, groynes and breakwaters. One of the most common methods for combating beach erosion is the construction of structures meant to protect beaches from the direct force of the ocean, according to Benoit et al. (2007). Beach nourishment, the deposition of externally sourced sand on beaches, is another process meant to slow the coastal erosion. One advantage of this method is the low cost, however, as it is a temporary solution, it is a repeated cost. Furthermore, the Surfrider Foundation claims the introduction of non-native particles through beach nourishment, such as silt, can create turbid water and smother habitats, in addition to creating drop-offs that pose a danger to swimmers.

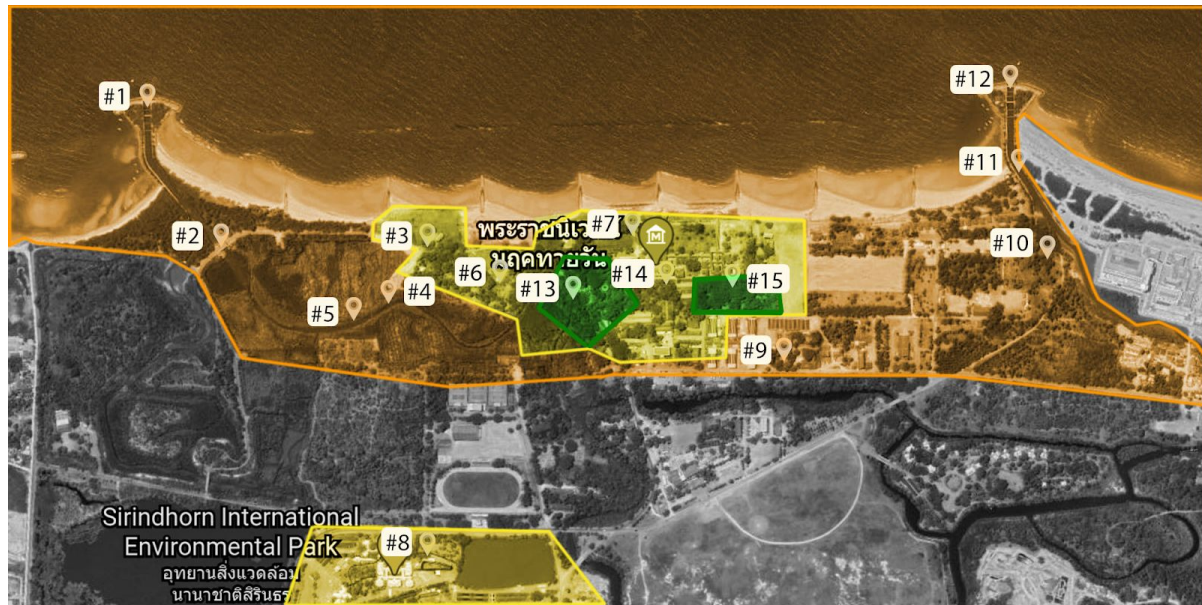
Goundwater Salinity Gradient at the Mrigadayavan Palace

The gradient maps show similar information. The areas around the jetties have higher salinity levels surrounding them (orange in color) that show how they are more affected. While the palace grounds show a brackish state, yellow, with some freshwater areas, green.

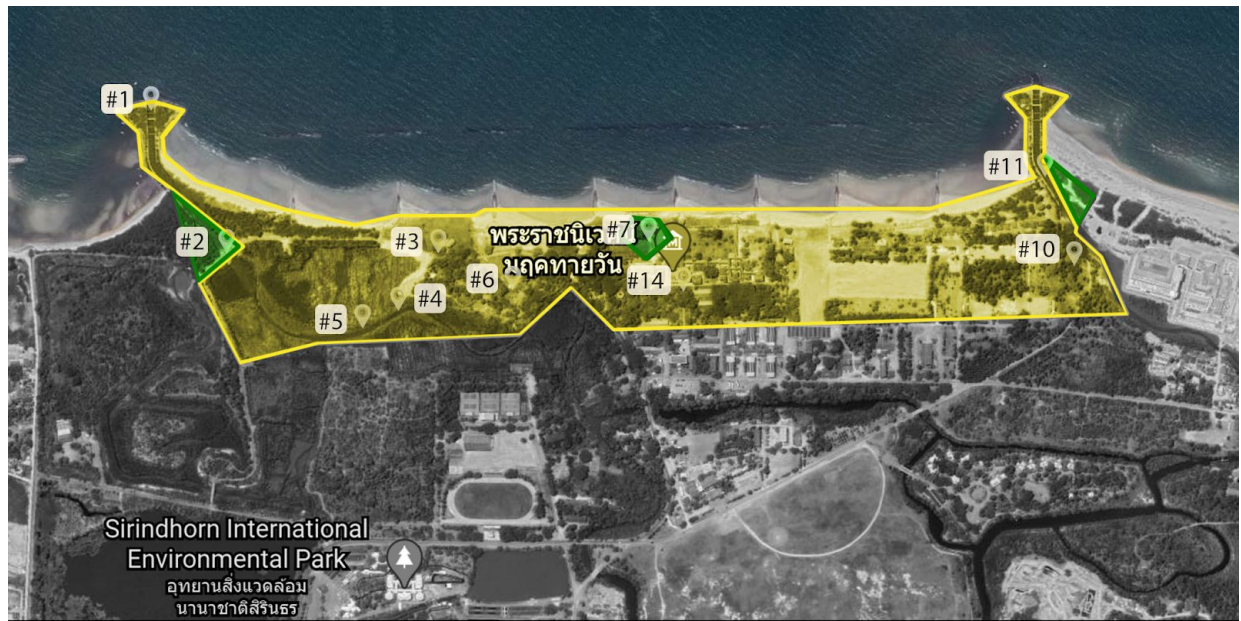
Figure 13: Gradient Map of Soil Salinity

Our soil sample results show that three of the topsoil sample sights yield fresh groundwater, but the remaining seven samples that were tested were all brackish. Topsoil samples at site location #2 and #11 were likely under 0.5 ppt because they were located directly next to the concrete jetty structures which prevented the seawater from being able to seep into the soil.

Soil Salinity Gradient at the Mrigadayavan Palace

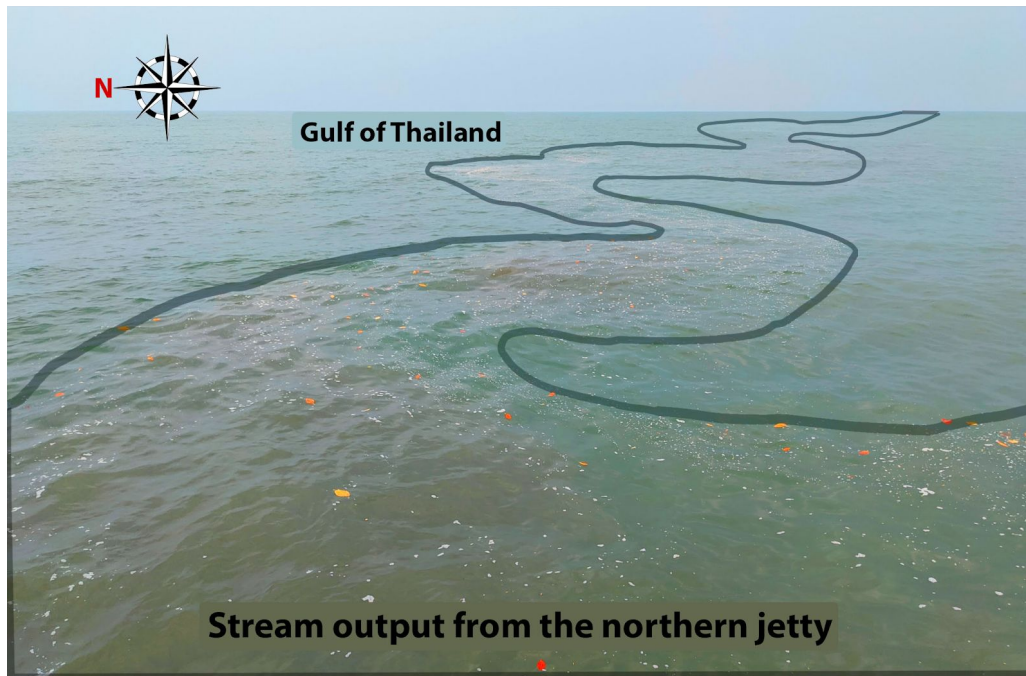
Figure 15: Photo of Sediment in Gulf

Although the primary function of jetties is to allow seawater to flow inland, water exits into the ocean due to the tides, as well. As outlined in [Figure 15](#), there is a stream of discolored water where sediment from the land, likely the mangrove forest, has mixed with outflowing water.

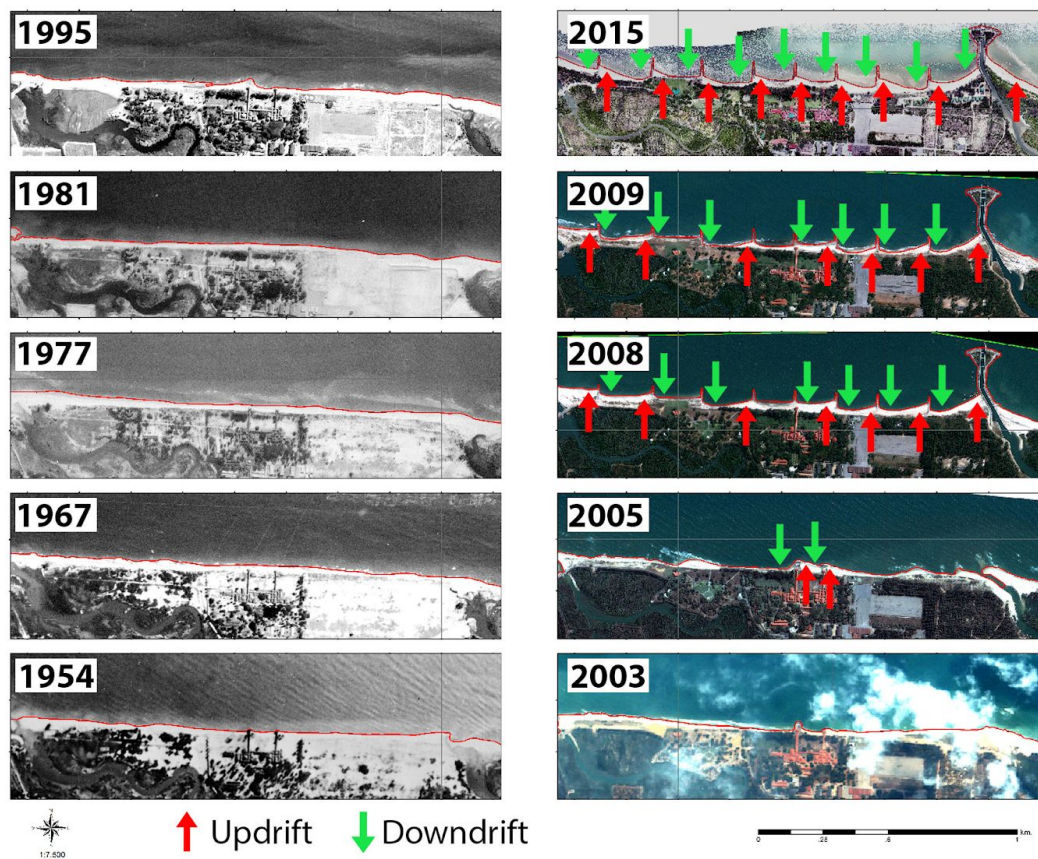
Figure 16: Flow of Updrift and Downdrift of the Mrigadayavan Palace's Shoreline

There are notable changes in the shape of the shoreline between 1954 and 2019, especially after the construction of the jetties in 2005, and groynes in the years following. The shoreline remained relatively constant between 1954 and 2005, the year the jetties were constructed. Even when it would misform, there is a visible tendency to even back out. However, the updrift, indicated by the red arrows in [Figure 16](#), and the downdrift, indicated by the green arrows, appears to be caused by the groynes and jetties, as they are not visible before 2005.

Although groynes are meant to protect beaches, these appear to be disturbing a shoreline that was not previously showing signs of erosion.

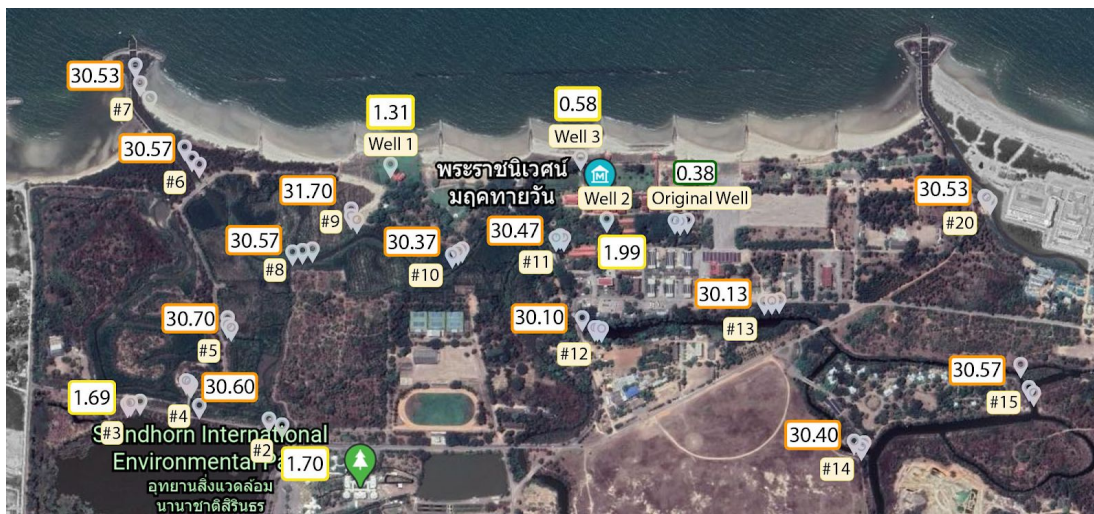
These charts show the data we received from our meeting with our sponsor.

- Sampling Location
- Site Number
- Salinity Measurement

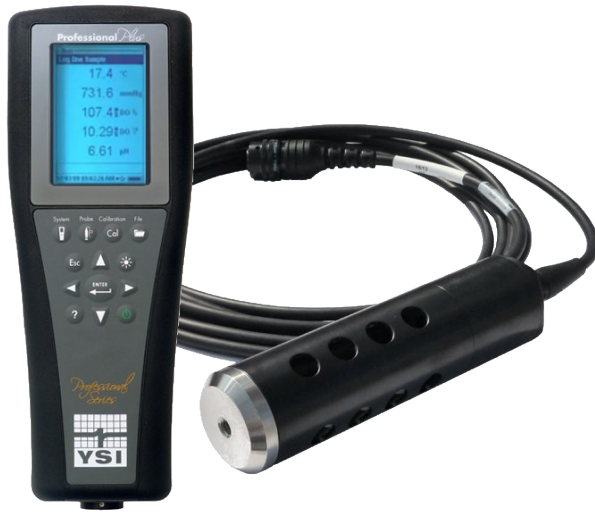
Appendix E: The YSI Salinometer

1. This device only measures between 0 to 50.0 parts per thousand
2. To turn on the device, press on the sunlight button for around 7 seconds
3. The cord should always be connected to the handheld device during measurement
4. During measurement, the whole head of the cord should be fully immersed in water
otherwise measurements will not be accurate
5. While the head of the cord is fully immersed in water, it is recommended for the user to
move the head of the chord a bit for more accurate results
6. Stabilization of salinity measurements require fifteen seconds
7. The temperature of the water (Celsius) and the salinity of the water (in parts per
thousand) will come up on the device
8. After you're done using the device, wash the head of the chord with freshwater until the
readings go back to 0.0

We conducted our own testing of the groundwater salinity using a YSI Salinometer set from Chulalongkorn University. The YSI Salinometer measures the conductivity of the water and converts the conductivity measurement to a salinity measurement in parts per thousand. The probe of the salinometer was submerged 0.5 meters below the surface of the water. The team mapped where on the Palace grounds the samples were taken, and the results were later compared to the data given by the Mrigadayavan Palace.
